AN *IN VITRO* STUDY OF COMPOSITE REPAIR

**A minithesis submitted in partial fulfillment of the requirements for
the degree of Master of Science in Dental Sciences in Restorative
Dentistry at the Faculty of Dentistry University of the Western Cape**

October 2007

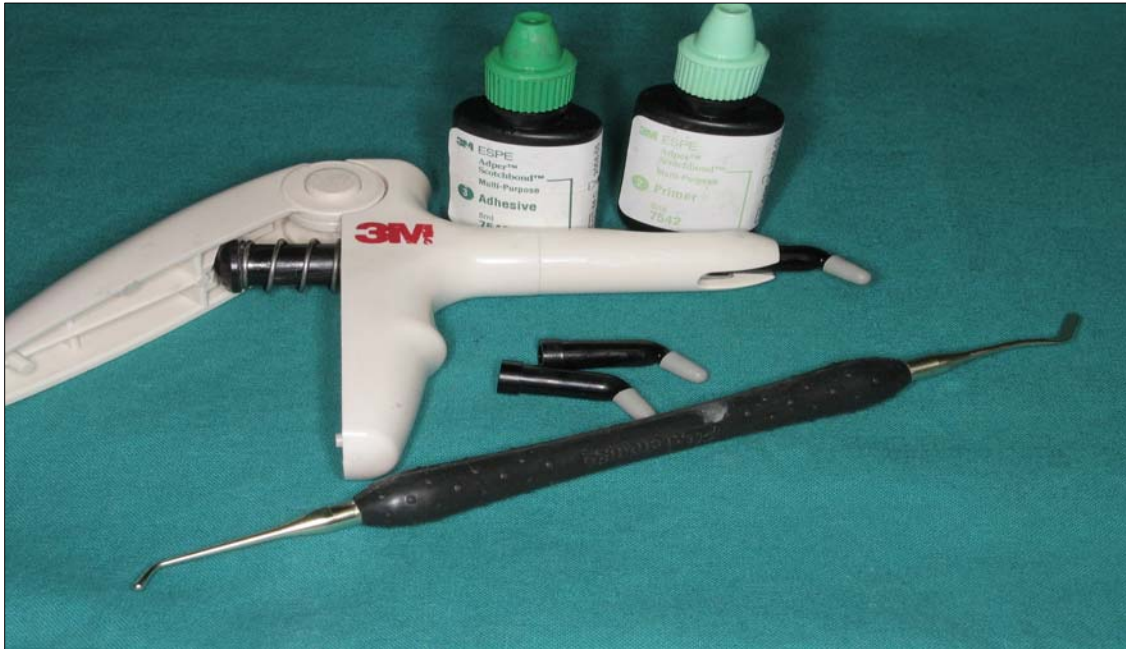
Fig 3.1: Composite + Adhesive + Composite placement instrument

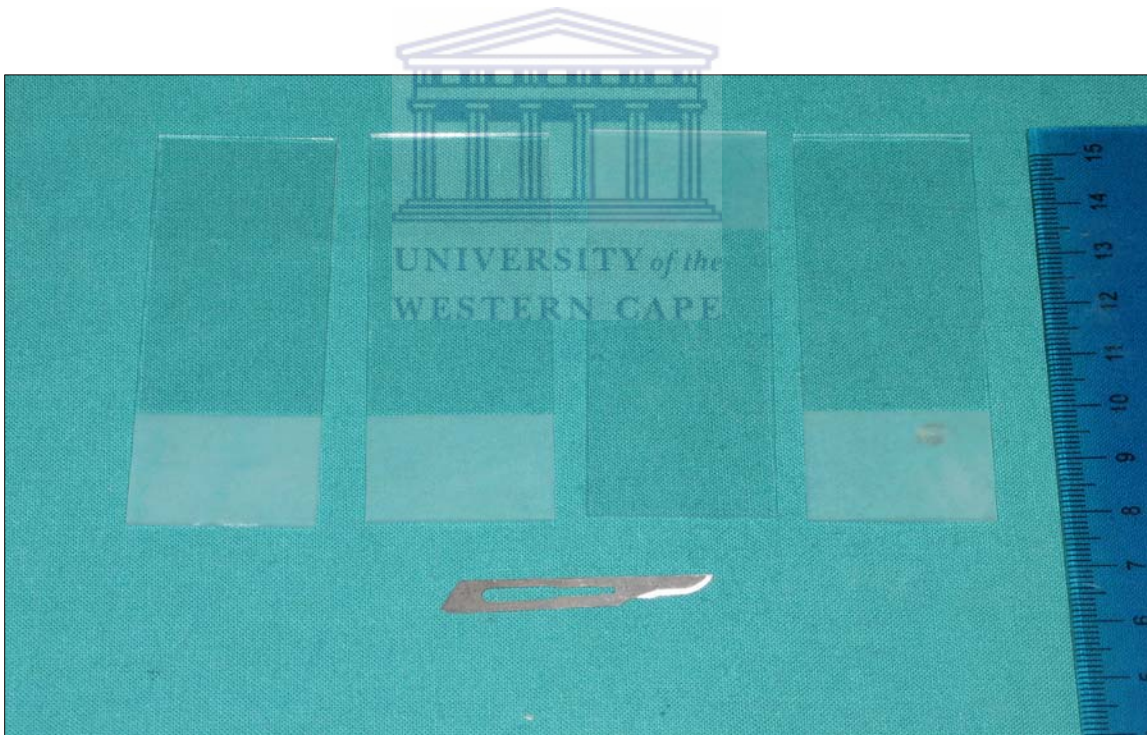
Fig 3.2: Glass Slides + Blade + Ruler

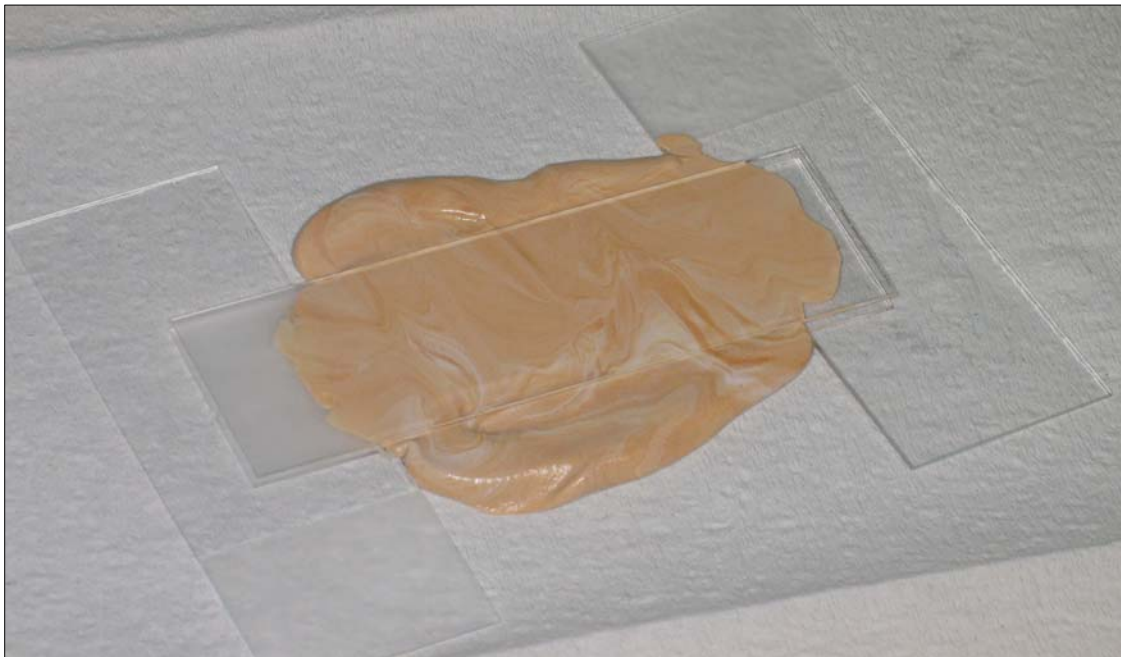
Fig 3.3: Using Silicone Putty to make a customized Silicone Mould

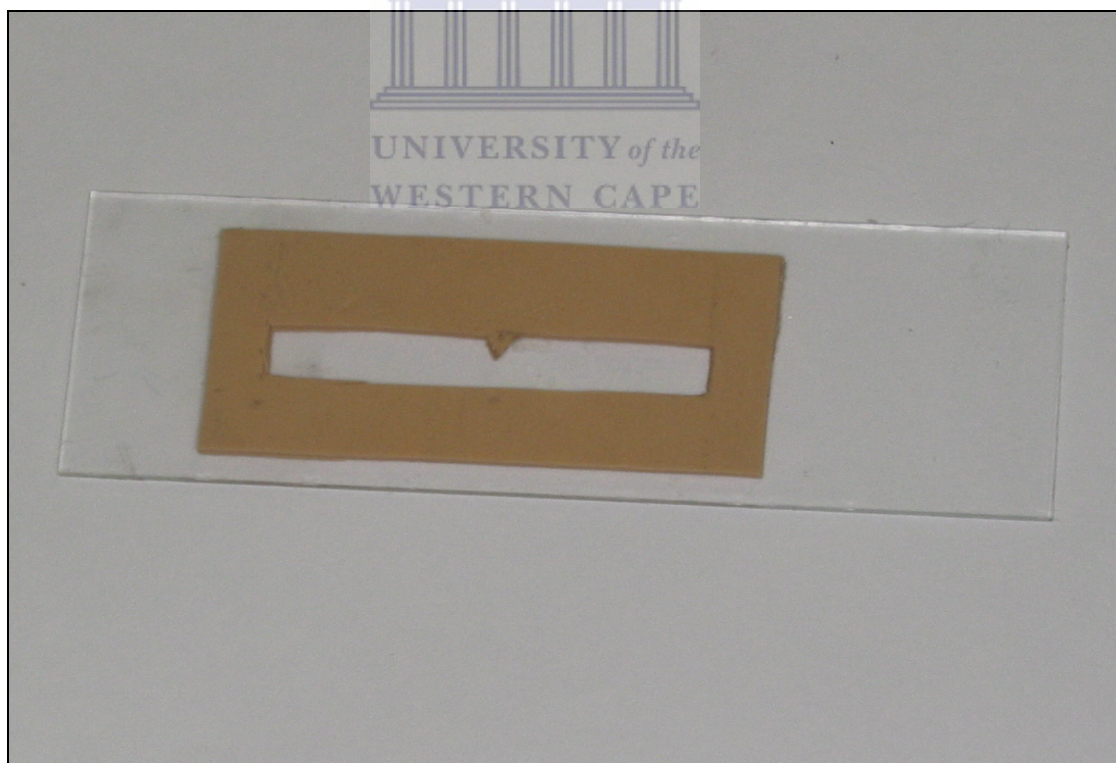
Fig 3.4: Silicone Mould with Notch for Specimen Preparation

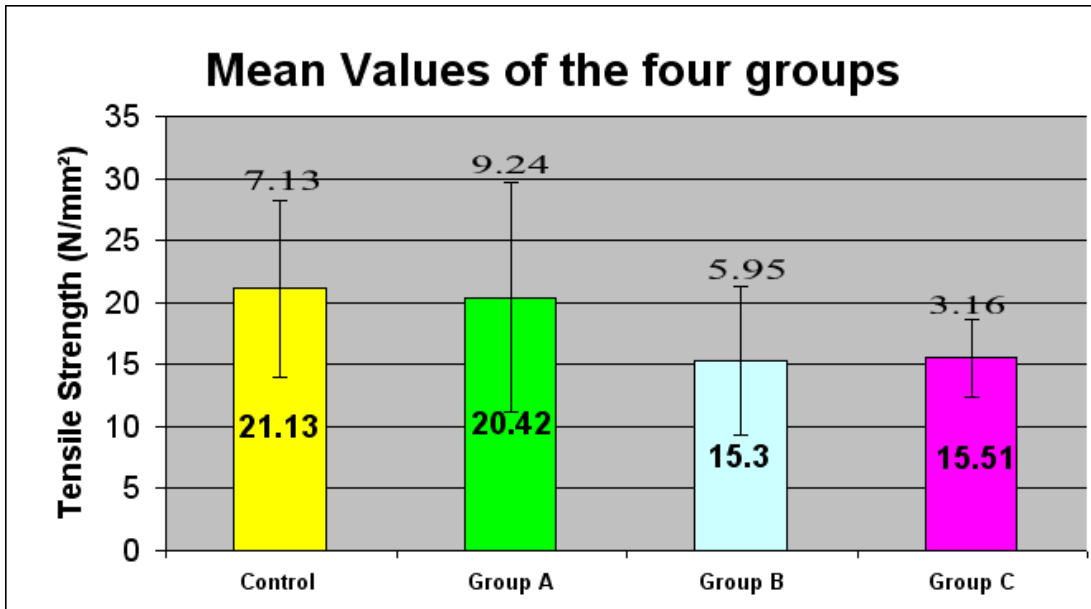
Fig 4.1: Bar graph demonstrating the mean tensile bond strength of the four groups

These data are summarized in Table 4.5 and graphically represented in Figure 4.1.

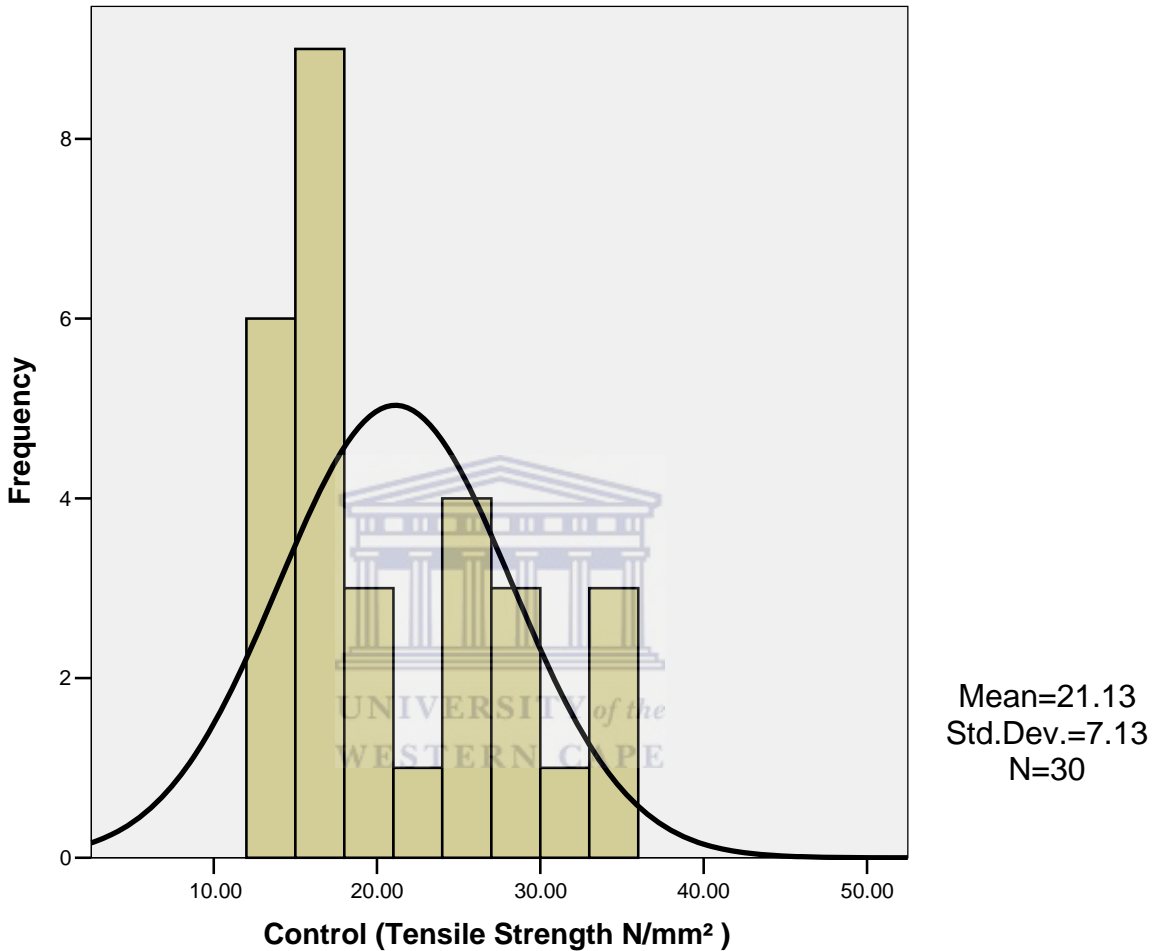
Fig 4.2: Graph showing the Distribution of the Results of the Control gorup

Figure 4.2 graphically illustrates the distribution of the specimens of the control group ranging in the tensile bond strength from 12.01 N/mm² to 35.87 N/mm². The distribution seems like a normal curve with four specimens around the mean. There were four specimens ranging in tensile bond strength from 30 to 35 N/mm² and this may have had an influence on the mean value of 21.13 N/mm².

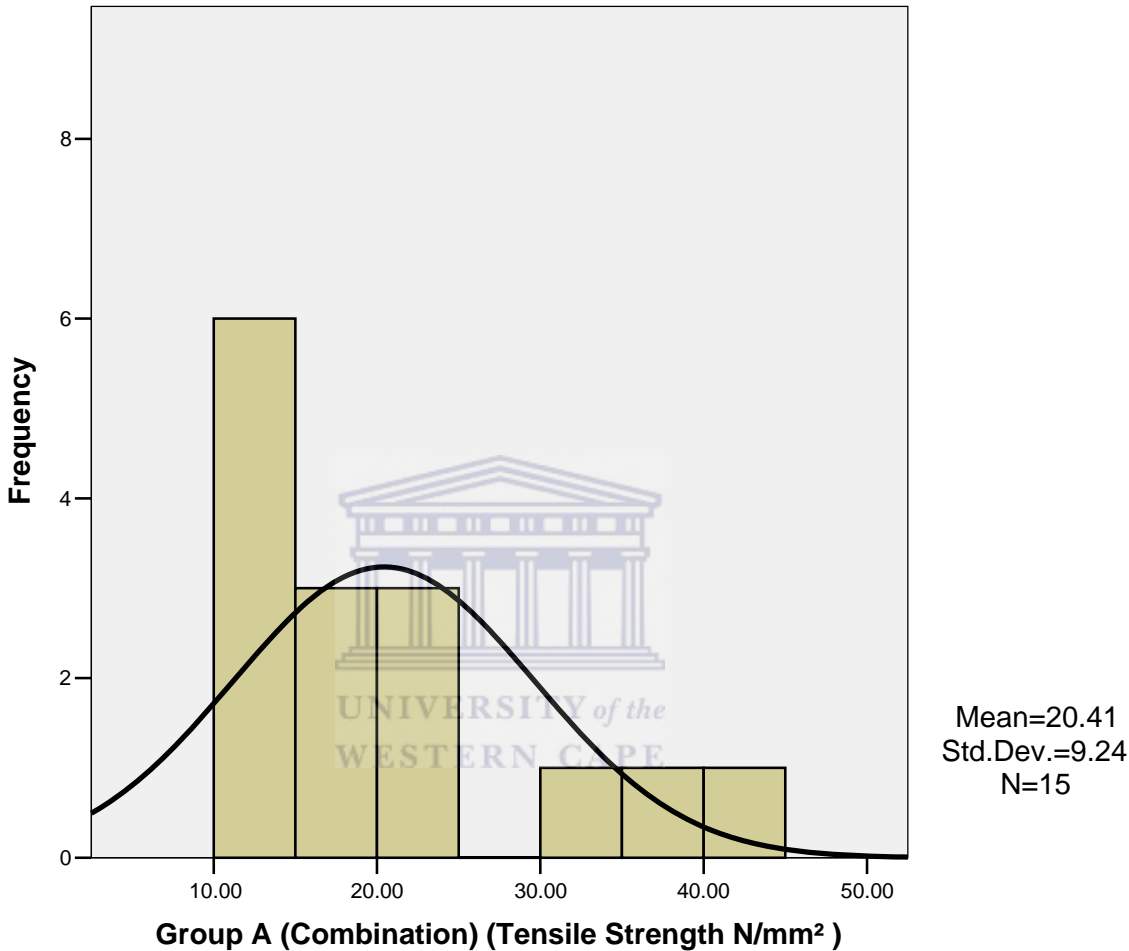
Fig 4.2: Graph showing the Distribution of the Results of Group A

Figure 4.2 graphically illustrates the distribution of the specimens of group A ranging in the tensile bond strength from 10.85 N/mm² to 40.72 N/mm². There were seven specimens ranging in tensile bond strength from 10 to 15 N/mm². It is also noticeable that there were no specimens in the range from 25 to 30 N/mm².

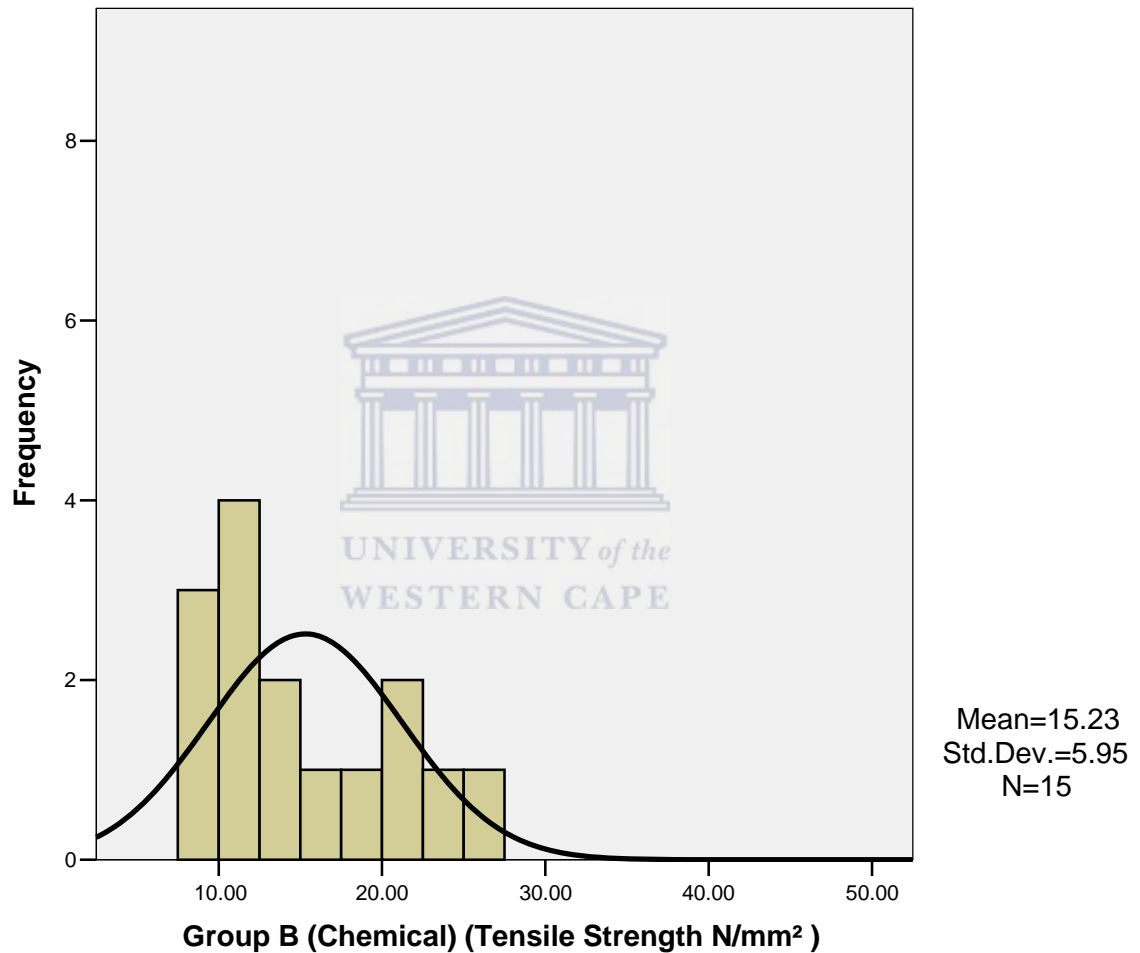
Fig 4.3: Graph showing the Distribution of the Results of Group B

Figure 4.3 graphically illustrates the distribution of the specimens of group B in the tensile bond strength ranging from 9.02 N/mm² to 27.25 N/mm². There were seven specimens ranging in tensile bond strength from 9 to 13 N/mm². There was only one specimen above 25 and this may have had an influence on the mean value of 15.23 N/mm².

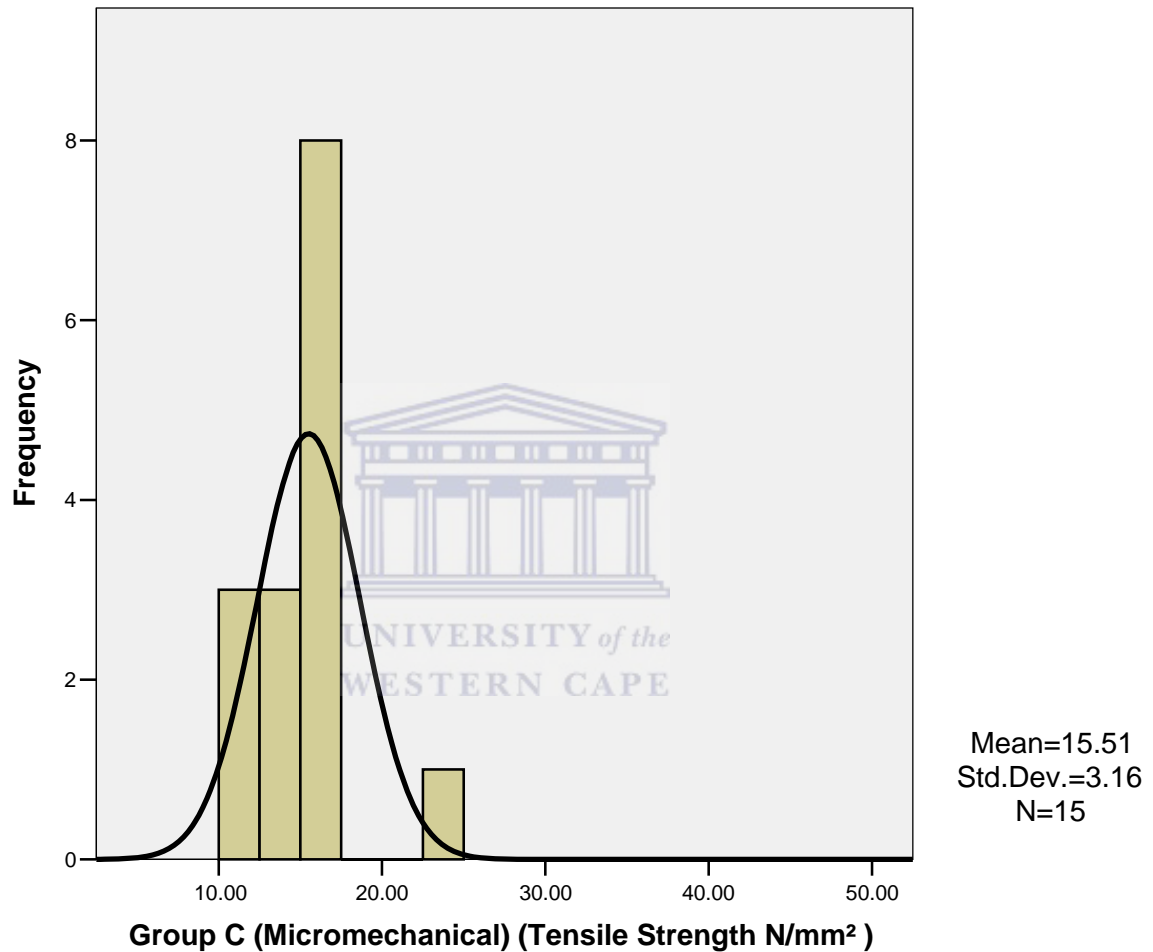
Fig 4.4: Graph showing the Distribution of the Results of Group C

Figure 4.4 graphically illustrates the distribution of the specimens of group C in the tensile bond strength ranging from 11.87 N/mm² to 24.83 N/mm². There were eleven specimens ranging in tensile bond strength from 14 to 17 N/mm². It is noticeable that most of the specimens were dispersed around the mean. There was only one specimen above 20 and none in the gap between 18 N/mm² and the maximum reading, this may have had an influence on the mean value of 15.51 N/mm².
