UNIVERSITY *of the*
WESTERN CAPE

MASTERS FULL-THESIS: 2018-2019

**Estimating the Potential for Natural Ecosystem Recovery at the
Pietersielieskloof Palmiet Wetland, Western Cape.**

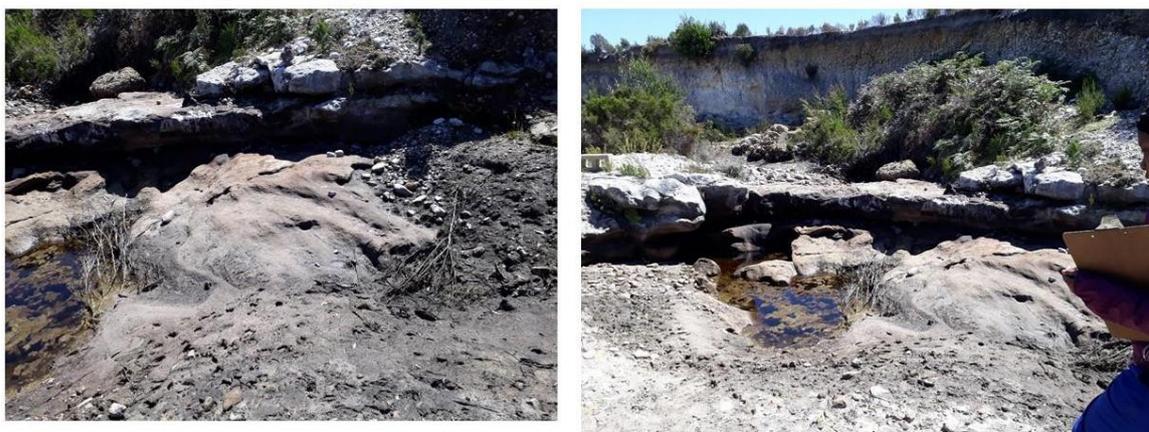
Figure 13: The inset meandering reach is characterised by deep scouring and erosion up to 6 m deep into alluvium.

Upstream in the inset meandering channel from the headwaters indicated in blue above which is above the road, and in the reach highlighted in red, sediment is produced where gullies are eroded and valley floor scouring occurs (**Figure 13**) for downstream deposit.

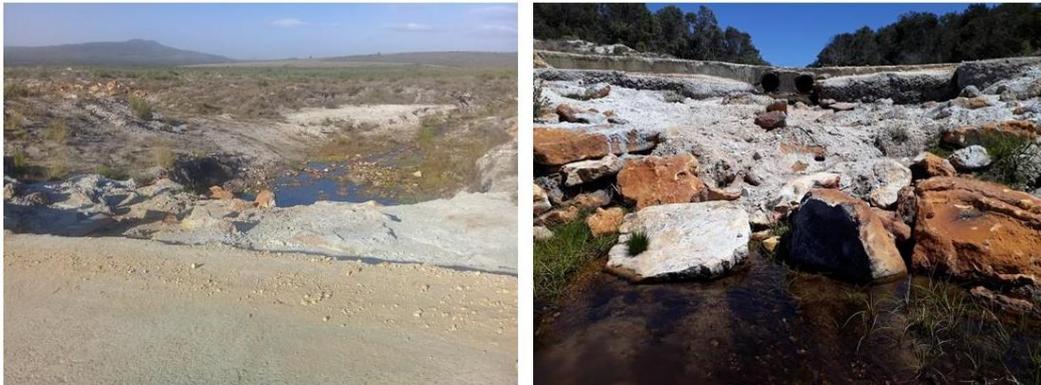
Figure 14: The area below the road indicated by the red colour in the long profile shows deep scouring.

The differences in slope before and after the inset meandering reach can be attributed to the channelisation of the water by the 16 culverts put in place at the Pietersielieskloof. The culverts in the road are 58 cm in diameter, 8 on the side of the Kiersgat tributary and 8 on the Boskloof arm. Concrete has been added to raise the road as well (**Figure 14**). The road creates a boundary between the Upper and Lower Kiersgat reaches and acts as a local base level. In Lower Kiersgat, sediment is also eroded vertically and laterally from the wetland valley fill. The sediment scoured at the head and the gully walls create a depositional feature immediately downstream (indicated green in the longitudinal profile) due to the in-channel deposition of sediment, which has a steeper slope than reaches upstream and downstream.

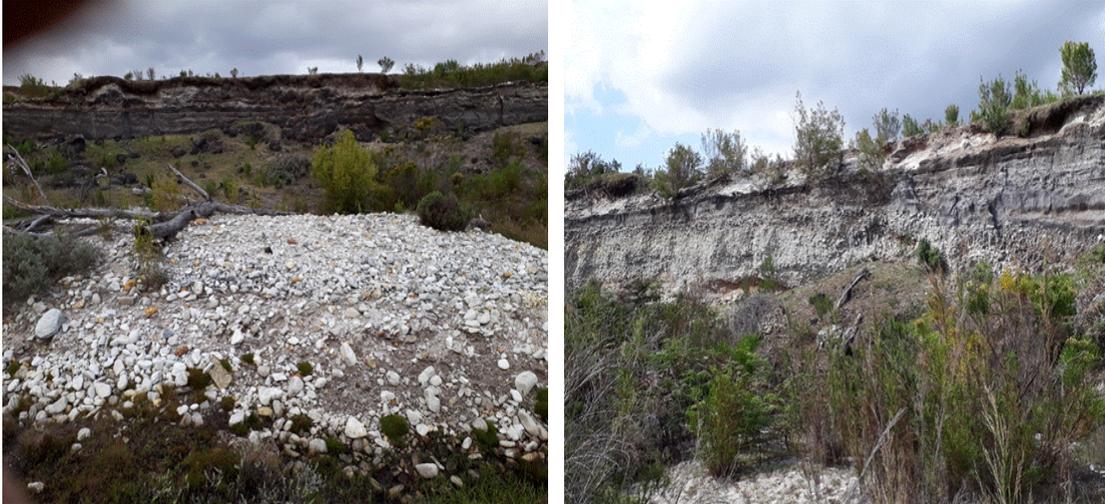
Figure 15: Cobbles and colluvium are found in the Upper Kiersgat tributary.

The wetland is dominated by clastic sediment, with some unconsolidated colluvium sediments underlying the alluvium sandy wetland deposits in some locations. Several gravel bars can also be found upstream of the valley-bottom wetland at Upper Kiersgat. The alluvial deposits at Upper and Lower Kiersgat valley floor are largely consolidated cobble and gravel bars that predate the wetland, as well as sand and coarse silt. The channel has eroded the valley floor in some areas which has created knickpoints in the inset meandering reach causing a sudden change in slope. In this portion of the wetland, the thalweg intersects consolidated gravel and cobble alluvial sediment that predates the intact wetland (**Figure 15**).

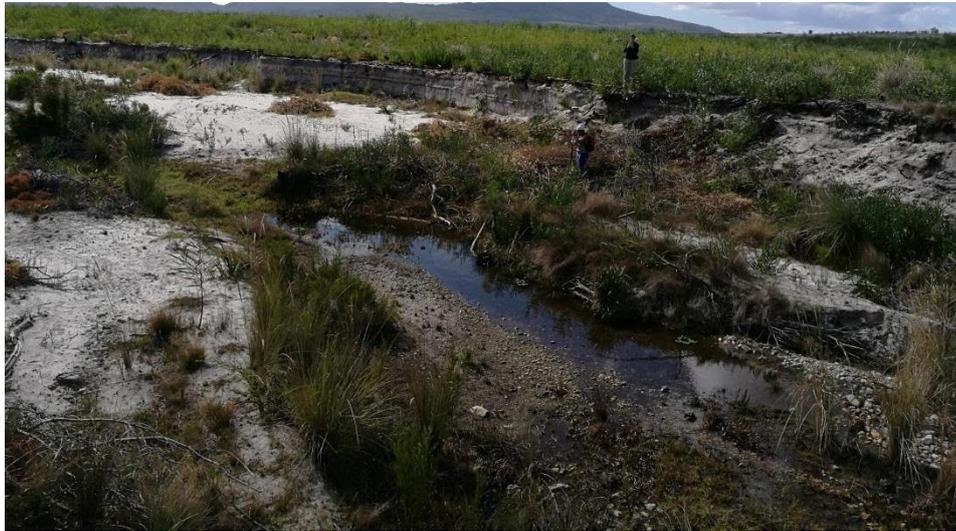
Figure 19: The widened gully inset within the valley floor.

The valley is dominated by clastic sandy sediment. Old gravel and cobble beds that have been exposed by erosion can be found in this reach of the incised channel (**Figure 19**).

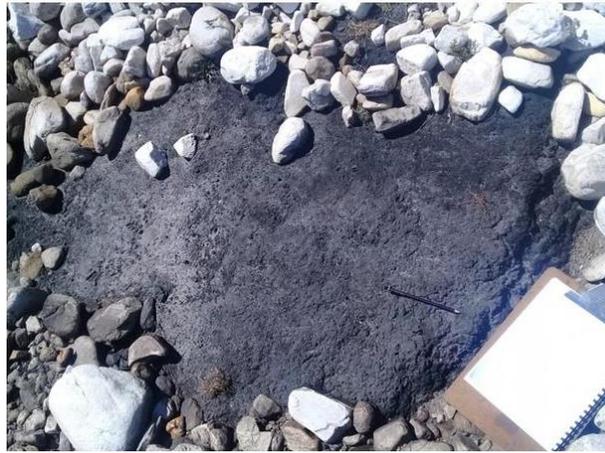
Figure 29: A buried organic layer on the valley-floor exposed by erosion.

The floor's organic matter in **Figure 29** was found to extend up to 3 m deep and the cross-section of the valley is displayed by **Figure 30**. Above the organic clay, there was gleyed sand and a cobble layer topped with soil. The valley floor's minimum accumulation rate at this site is 0.09 cm. yr^{-1} .
