**The impacts of channelisation on the geomorphology and ecology
of the Kuils River, Western Cape, South Africa**

Ruth-Mary Corné Fisher

A thesis submitted in partial fulfilment of the requirements for the degree of Magister
Scientiae in the Department of Earth Sciences, University of the Western Cape

September 2003

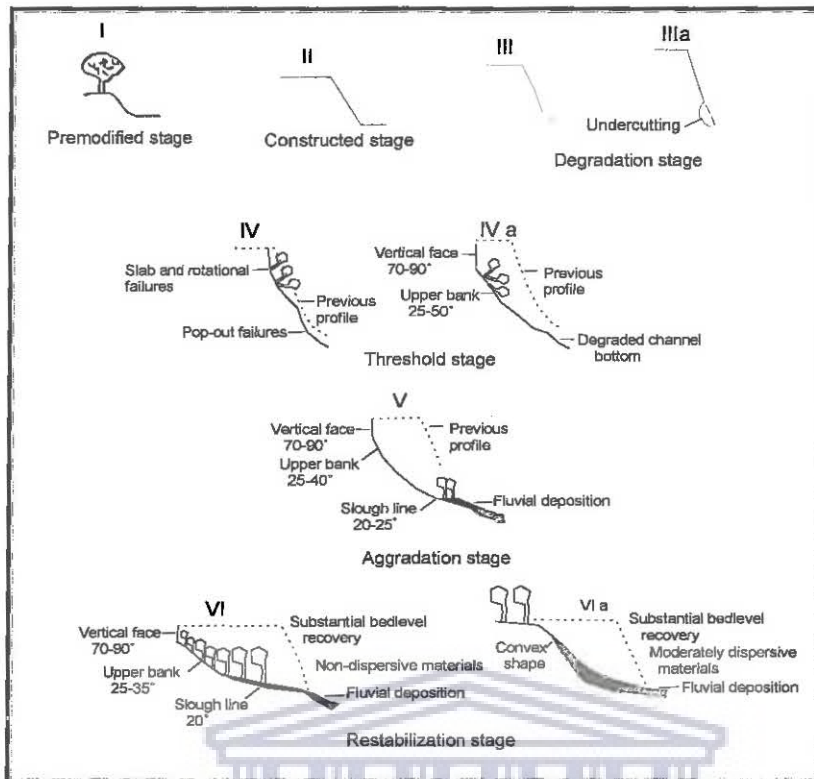
Figure 2.1: Stages of bank retreat and slope development. (From Simon 1989:20).

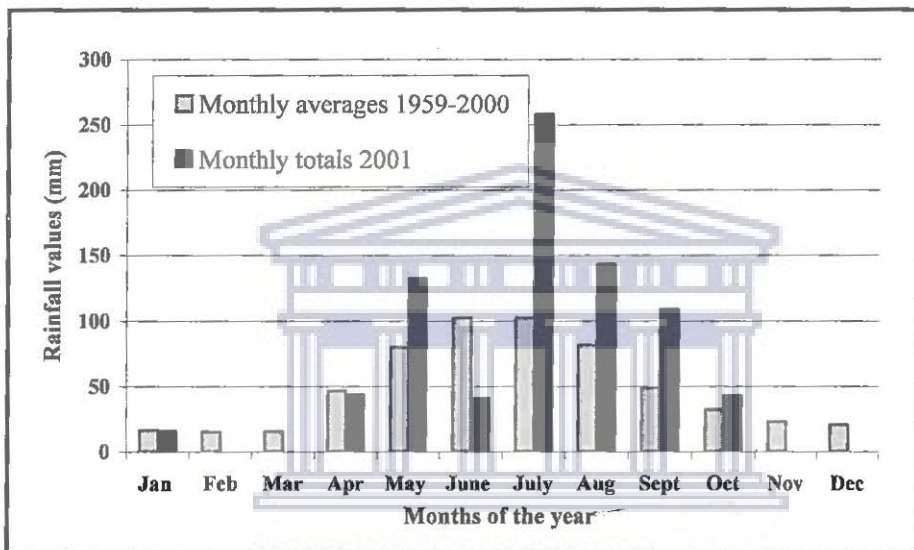
Figure 3.3: Rainfall data measured at Durbanville (T. de Villiers, local farmer, Durbanville area). The Western Cape received exceptionally high rainfall from May to September 2001.

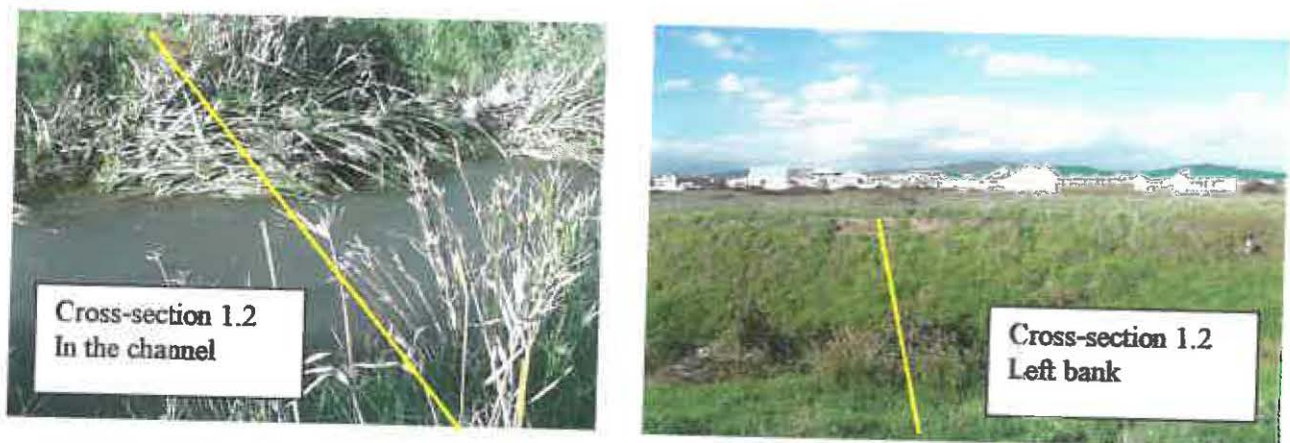
Plate 3.1: Site 1 at the beginning of the study period (January 2001). The line indicates the position of the cross-section. Note the narrow confined channel and the banks covered with *Pennisetum clandestinum* (kikuyu) and alien weeds.

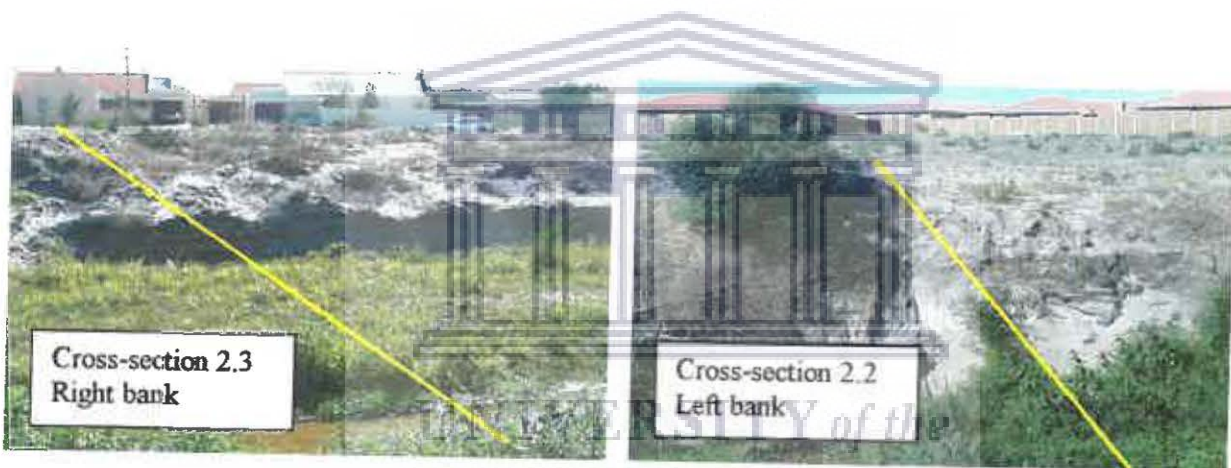
Plate 3.2: Site 2 at the beginning of the study period – January 2001. Lines indicate the position of the cross-sections. Note the crumbling banks and sparse vegetation cover (mostly alien weeds and a few alien trees).

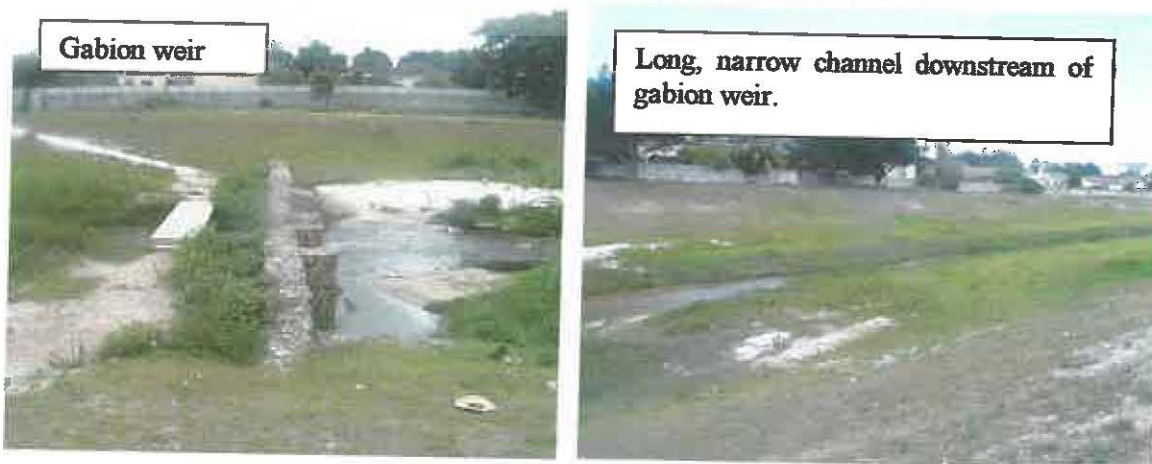
Plate 3.3: Site 3 at the beginning of the study period (January 2001).

designed to dissipate energy, was constructed within the section (Plate 3.3). Five cross-sections were established at this site in the summer of 2000/2001.

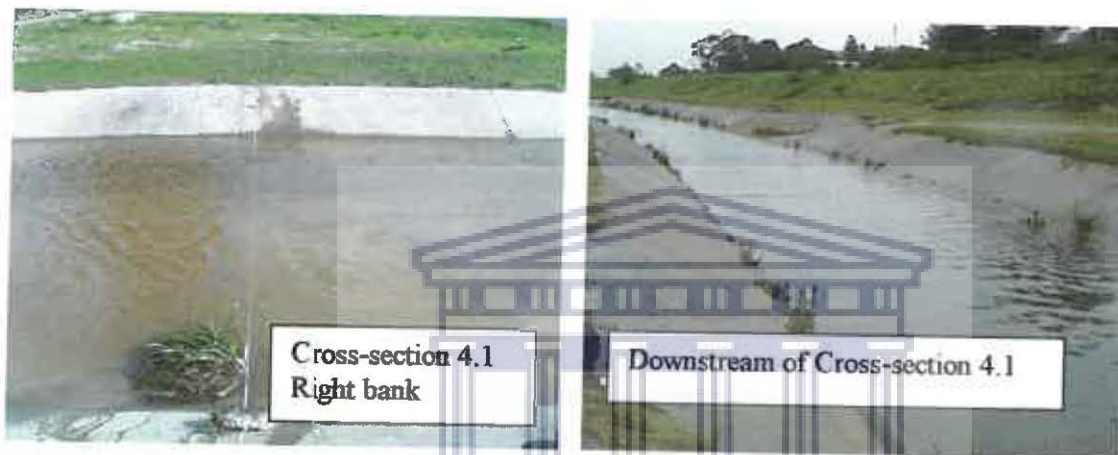
Plate 3.4: Description of Site 4. The measuring tape indicates the position of cross-section 4.1. This cross-section was used for the discharge-stage modelling (Section 4.5).

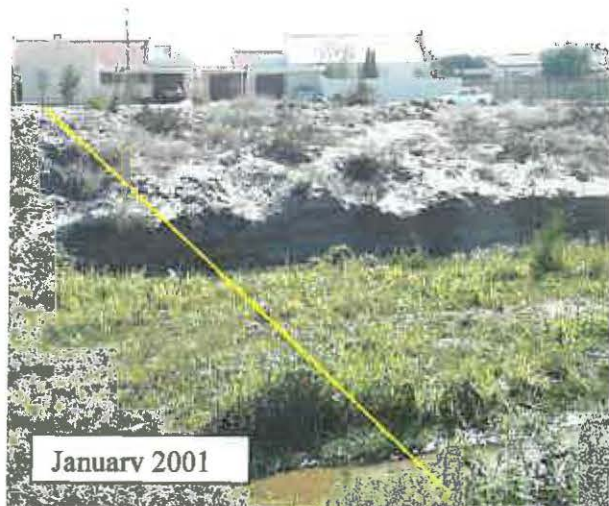
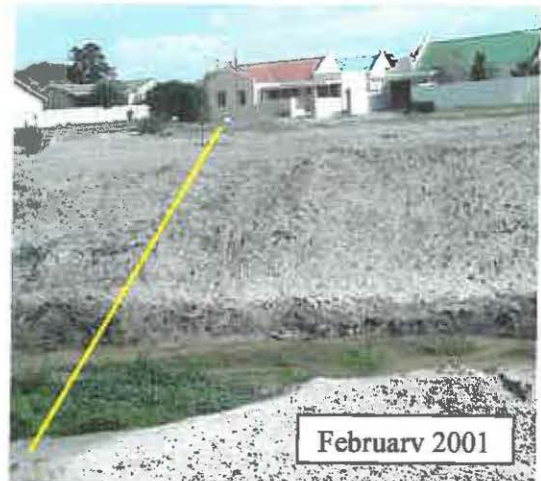
Plate 5.1: Cross-section 2.3 on the right bank before and after the channelisation. Flow was from the right to the left.

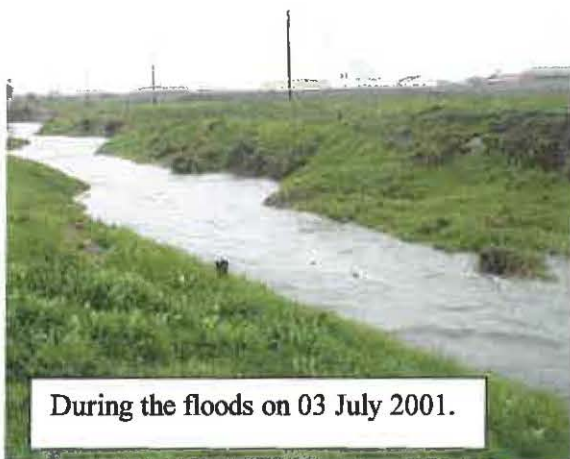
During the floods on 03 July 2001.

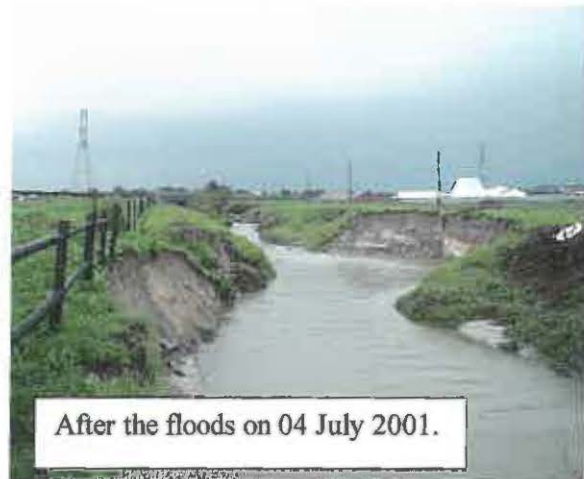
After the floods on 04 July 2001.

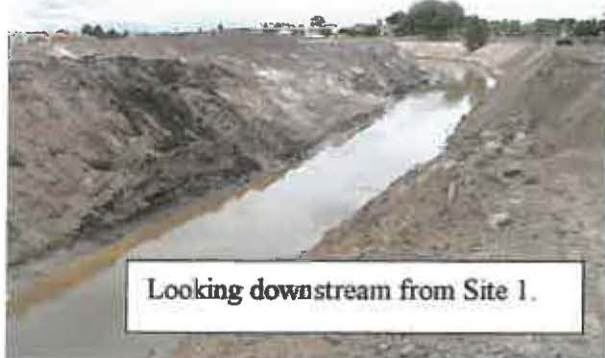
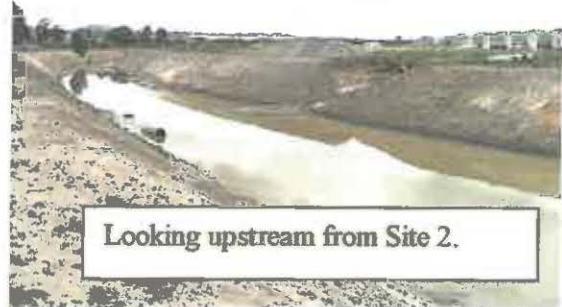
Plate 5.5: The straightened channel of Sites 1 and 2 after the October – November 2001 channelisation. The channelisation involved bulldozing the channel to straighten it. The banks were also straightened and widened.

Looking downstream from Site 1.

Looking upstream from Site 2.

during July 2001 (Plates 5.3 and 5.4) resulted in more than 5m of land being washed away on the left bank at cross-sections 1.1 and 1.3. The active channel of cross-section 1.2 widened by 2.5m and the midslope of the right bank (macro-channel) receded by 6.5m (indicated by arrows on Figure 5.2). The bank collapse also resulted in sediment being deposited in the channel as recorded at cross-section 1.1. The channelisation during October and November 2001 was an attempt to stabilize the banks of the river by re-grading them to an angle of about thirty degrees and furthermore resulted in a uniform straight channel. The channel was filled in on the right bank at cross-sections 1.2 and 1.3 and on the left bank at cross-section 1.1, resulting in a more or less trapezoidal cross-section (Figure 5.2 and Plate 5.5).

The channel of Site 2 was wider than that of Site 1 at the beginning of the study period, but the active channel itself was relatively narrow. The water's edge at all three measurement times is indicated with arrows on Figure 5.3. The channel also became wider in a downstream direction with cross-section 2.1 the narrowest and cross-section 2.4 the widest. The winter floods resulted in bank retreat on the left bank of more than 7.5m at cross-sections 2.1 and 2.3, and ± 10 m at cross-section 2.2. Bank retreat was less severe on the right bank with a retreat of ± 1.5 m at cross-section 2.1 and ± 5 m on cross-section 2.2, while the right bank of cross-section 2.3 experienced minimal erosion. Cross-section 2.4 experienced no bank erosion. The floods also resulted in sediment deposition within the channel as shown on cross-sections 2.2, 2.3 and 2.4 (Figure 5.3 and Plate 5.4). The channel bed was raised by ± 1 m at cross-section 2.3 and 2.4 and by 1.5m at cross-section 2.2 (Figure 5.3). Due to the channelisation the right bank receded a further 1.5m and 2m at cross-section 2.1 and 2.2 respectively. Reshaping of the left side of the channel at the last two cross-sections resulted in infilling and build up of about 2m of the bank (Figure 5.3 and Plate 5.5).

The channelisation of Site 3 during 2000 resulted in a wide trapezoidal shaped channel with a relatively narrow active channel and floodplain areas. The water's edge is indicated with arrows on Figure 5.4. There was no bank erosion as a result of the winter floods, but some deposition did occur on the floodplains (Plate 5.5). The active channel was lowered as shown on cross-sections 3.4 and 3.5 (Figure 5.4).

The processes of erosion and deposition, as described above, can also result in cross-sectional changes (Stover and Montgomery 2001). Changes due to erosion and deposition were evident in the cross-sections of Sites 1 and 2 after the July 2001 floods (Plate 5.5 and Figures 5.2 and 5.3) where the banks widened by more than 5m in some cases and the channel bed was raised by almost 1m. Changes in the cross-sections of Site 3 also occurred due to deposition (Figure 5.4 and Plate 5.6). Studies by Stover and Montgomery (2001) showed changes in channel width and bed elevation along the Skokomish River, Washington, USA. The bed of the South Fork Skokomish River incised more than 1m between 1940 and 1964. The mainstream Skokomish channel bed was raised through deposition of about 0.5m between 1934 and 1944 (Stover and Montgomery 2001).

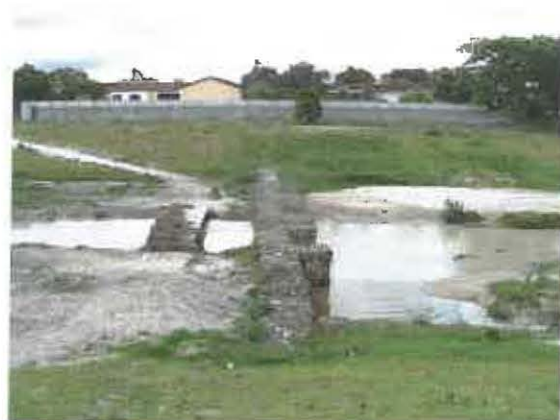
Plate 5.6: Sediment deposited on the floodplain area, within the channel and behind the gabion weir in Site 3 after the floods. The vegetation on the floodplain areas was completely buried under the sediment.

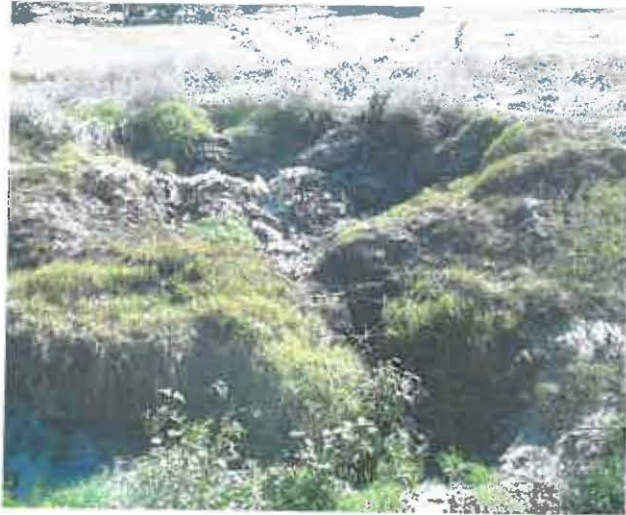
Plate 5.7: Depression with a storm water outlet filled with rubbish on right bank of Site 2 before the October – November 2001 channelisation. The presence of the pipe in the gabion was only noticed during the winter when water was seen coming from the outlet.

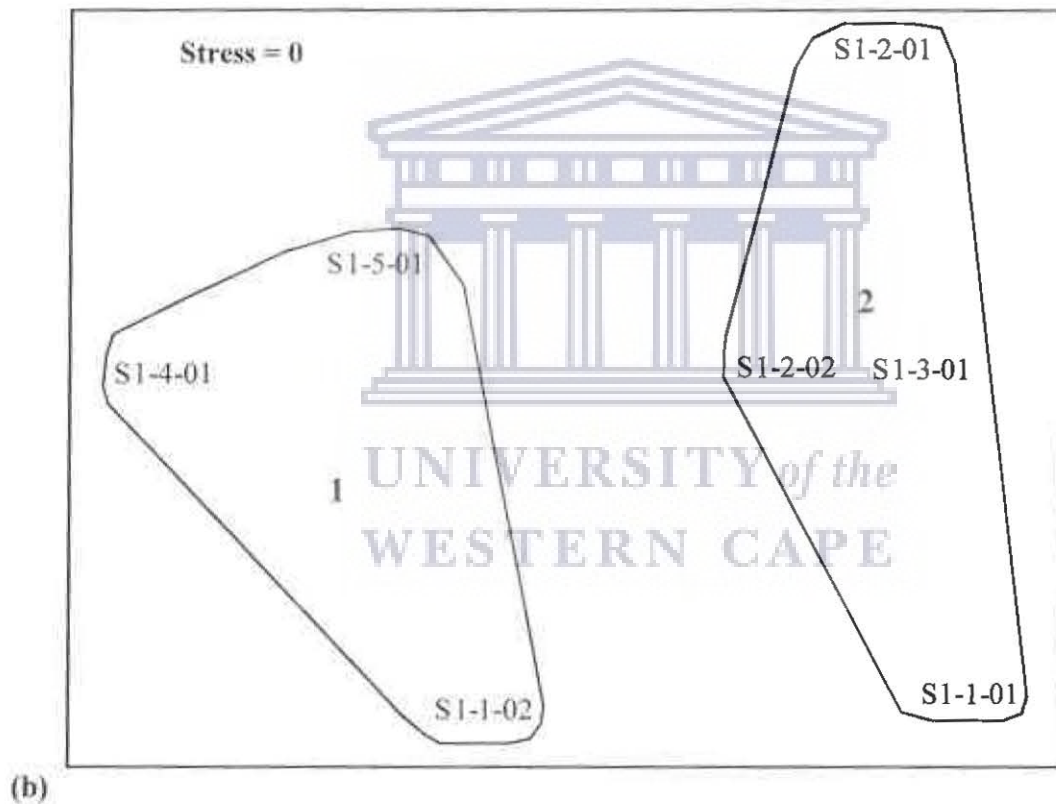
Figure 5.19: Dendrogram (a) and MDS (b) ordination of macro-invertebrate data from Site 1 for 2001 and 2002. Code: S1-1-01 – 6/SM = Site, sample number, year – hydraulic biotope number (Table 4.4) and flow type (Table 4.2).

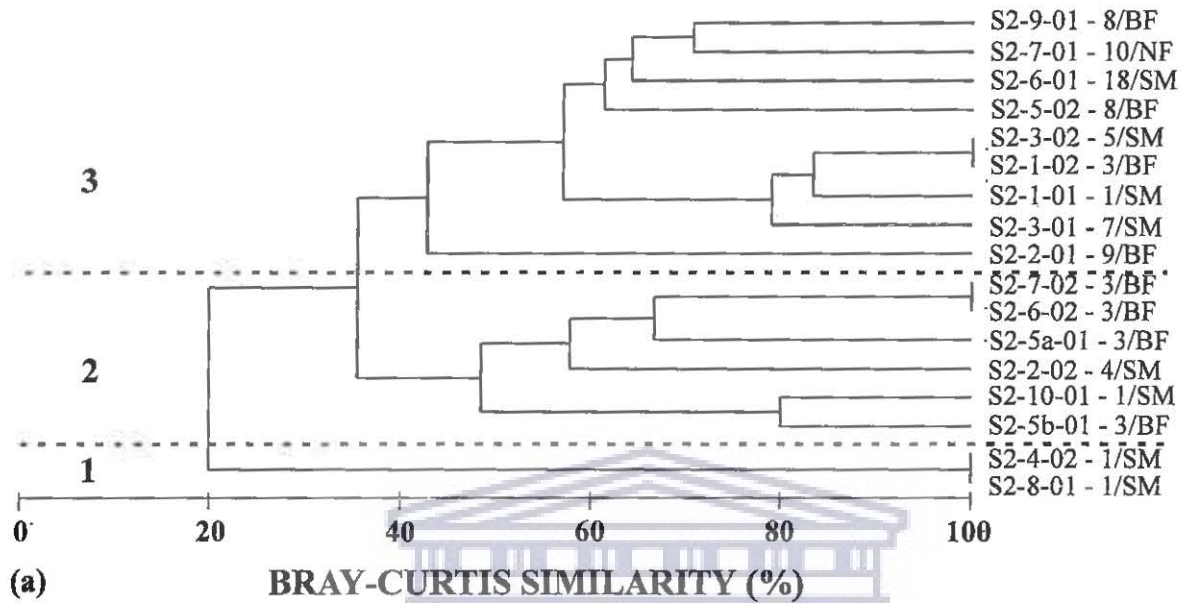
Figure 5.20: Dendrogram (a) and MDS (b) ordination of macro-invertebrate data from Site 2 for 2001 and 2002. Code: S2-1-01 – 6/SM = Site, sample number, year – hydraulic biotope number (Table 4.4) and flow type (Table 4.2).

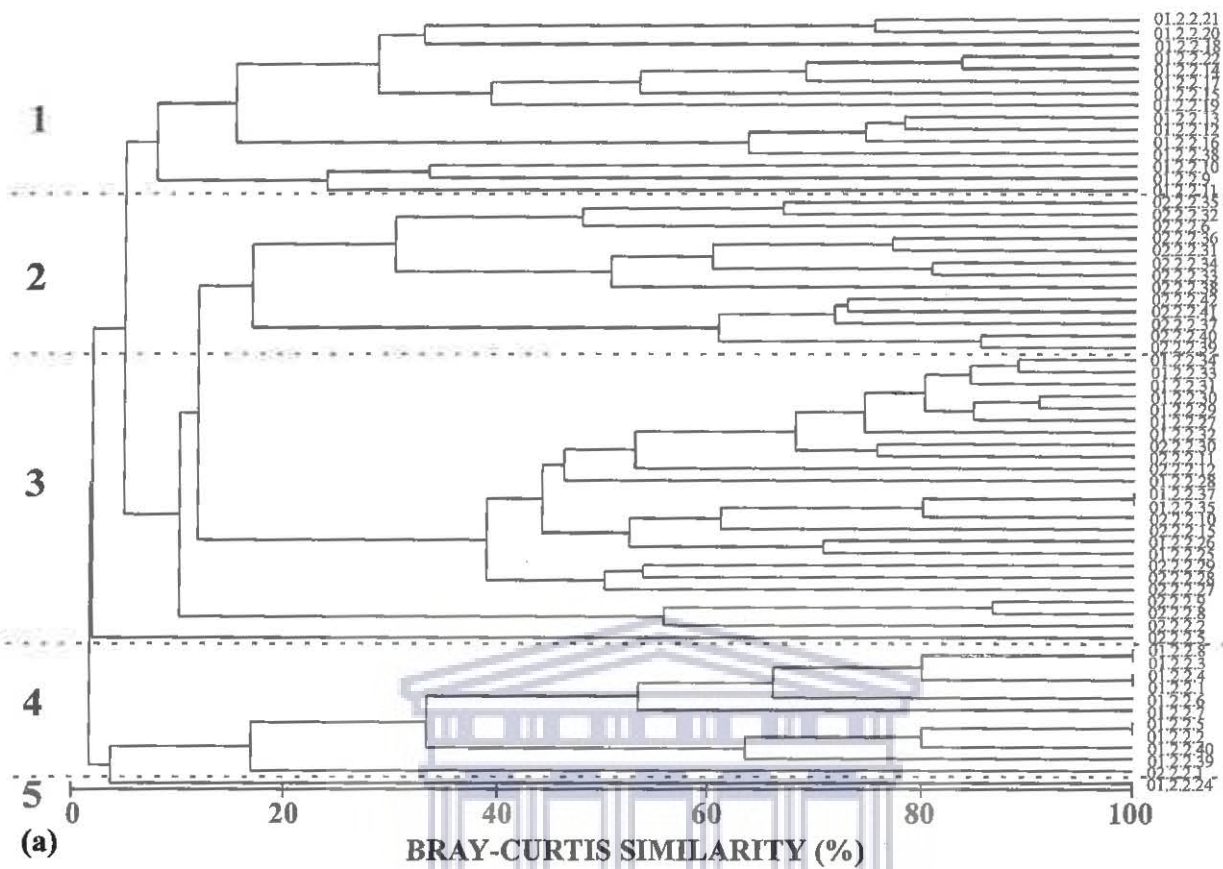
Figure 5.27: Dendrogram (a) and MDS plot (b) of the plant assemblages of vegetation transect 2.2 for 2001 and 2002. The bold numbers represent the groups identified while 01.2.2.1 is a code used for the sampling plots and represents year, site, vegetation transect and sampling plot.

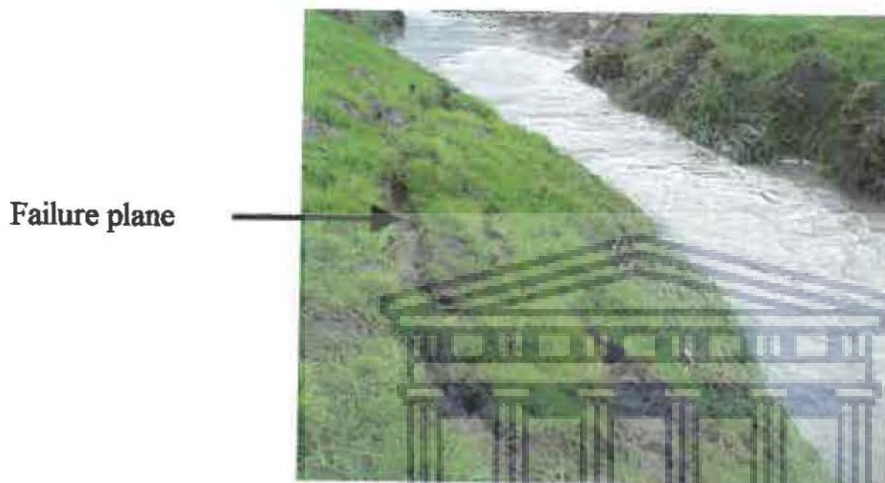
Plate 6.1: Failure plane along which the bank material on the right bank failed. The remaining material was still intact.

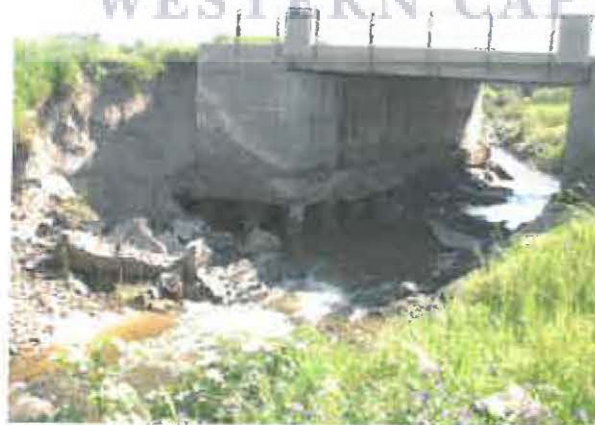
Plate 6.2: Undercutting of the Old Bottelary Road bridge pillars upstream of Site 1 – Photograph taken 02 September 2002.
