**Rapid geomorphological change in an urban estuary: a case study of the
Eerste River, Cape Town, South Africa.**

A mini-thesis submitted in partial fulfilment of the requirements for the degree of
Magister Scientiae in the Department of Earth Sciences, University of the
Western Cape

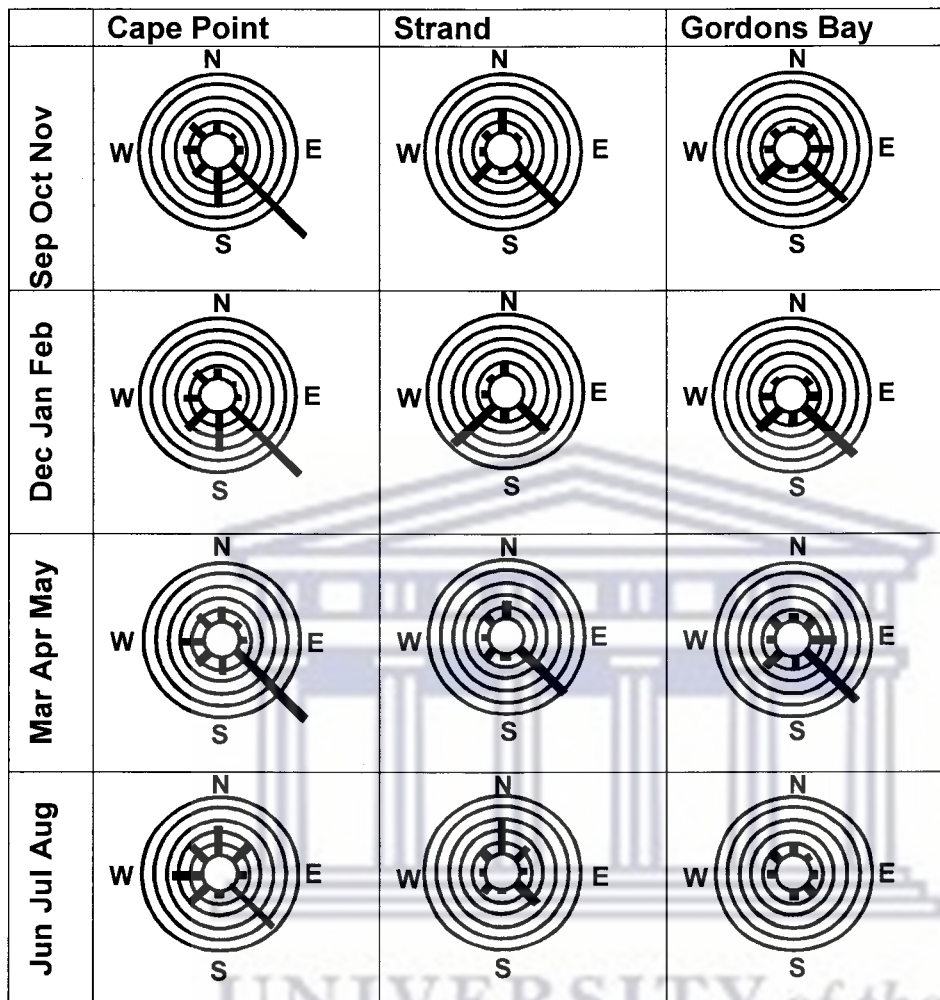
Figure 5. Wind roses for Cape Point, Strand and Gordons Bay (after Atkins, 1970)

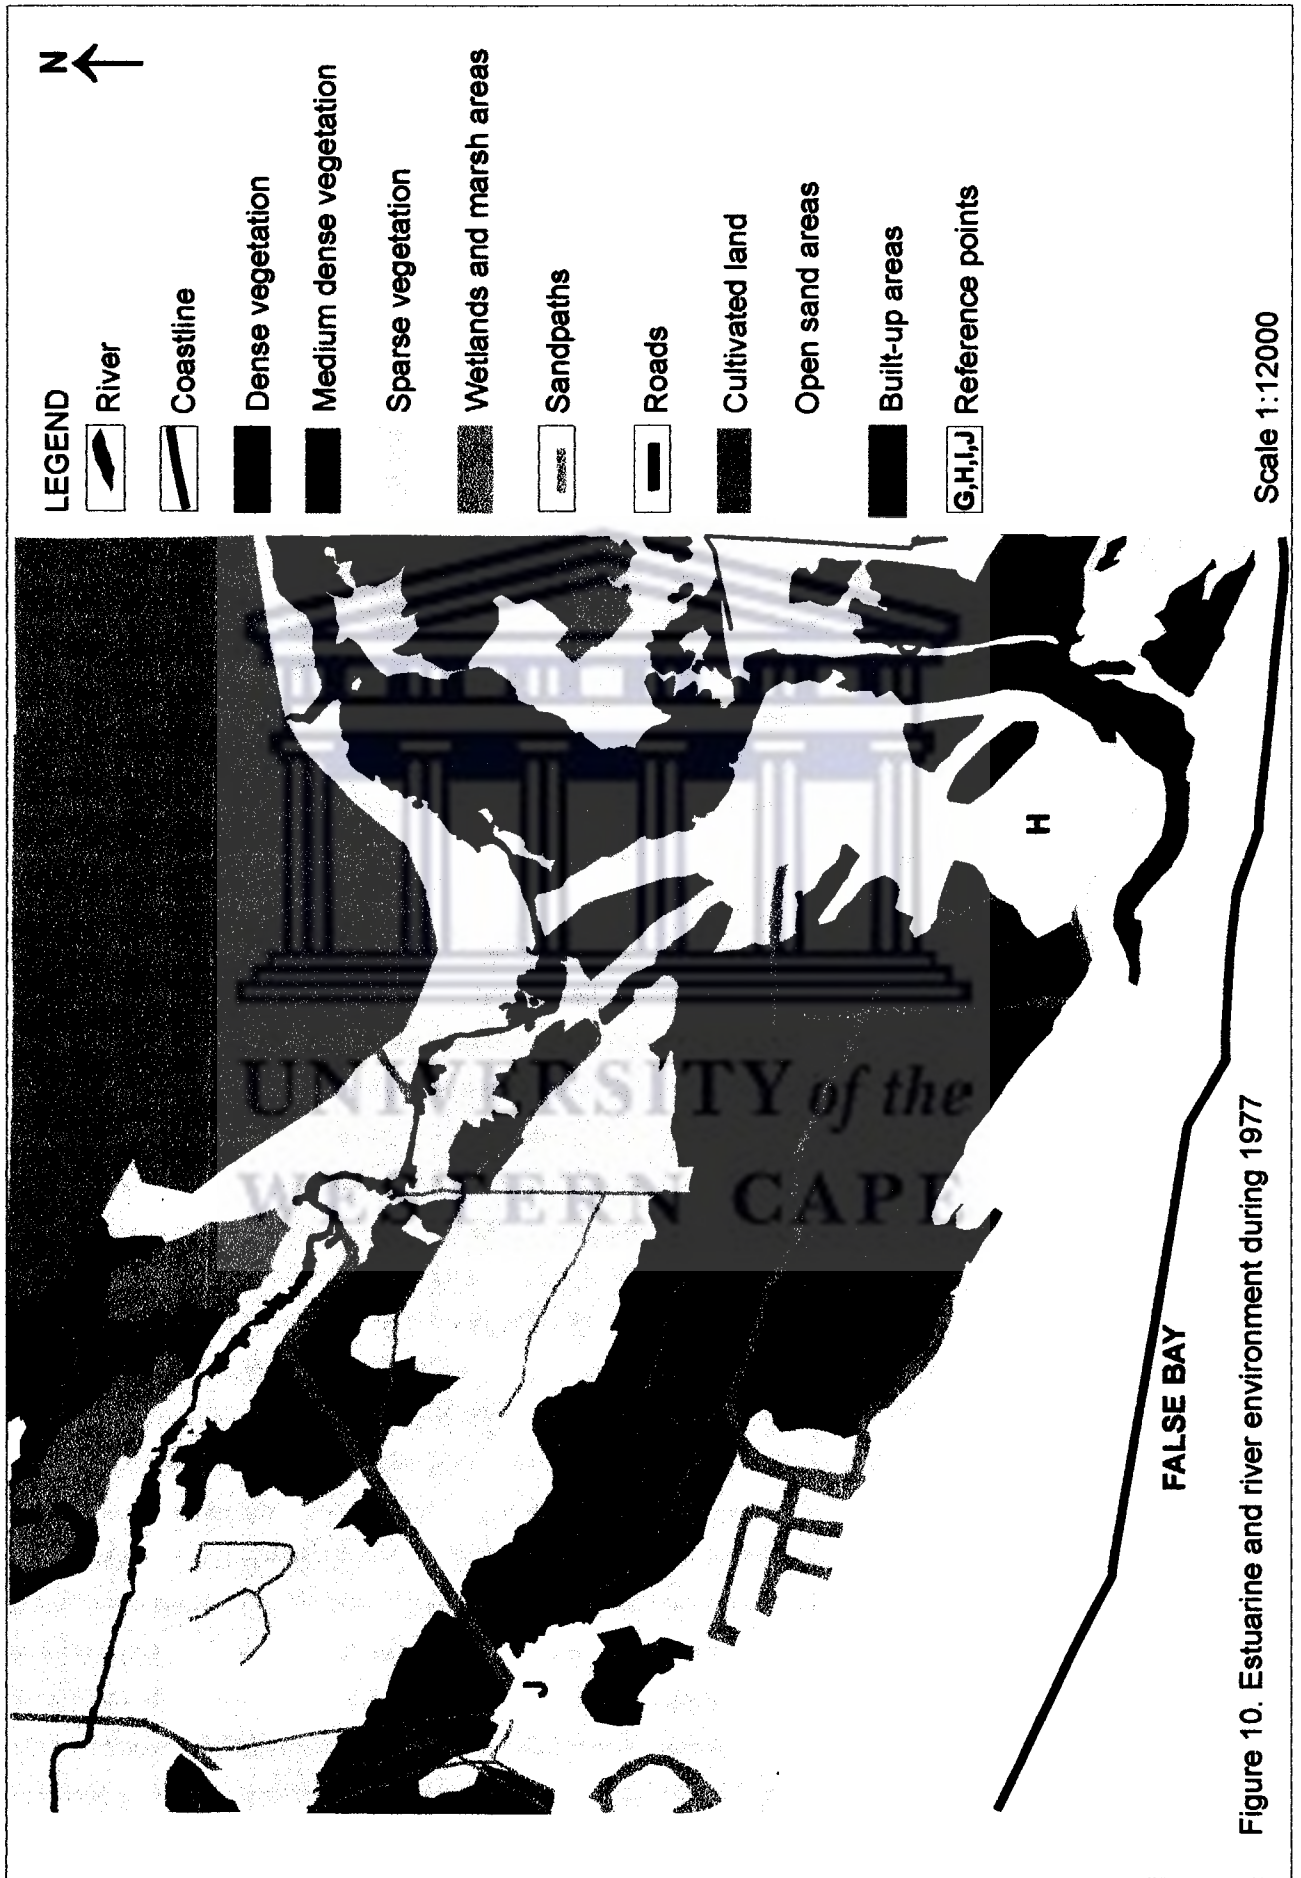
Figure 11. Estuarine and river environment during 1988

1988

The river reaches the sea in this photograph (taken during winter), forms a slight meander and shows westerly migration of 136m since 1977 along the beach (Figure 11). Seasonality was reduced due to changes in the hydrological characteristics of the river. Although the western lagoon parallel to the coast increased in area the outlet to the sea showed only a narrow channel. The eastern lagoon still exists and now forms part of a wetland with dense vegetation occurring on either side. More wetland development occurred on the dunes (K) in the vicinity of the now fully operational Macassar WWTW. Increases in hard surfaces and the discharge of treated sewage effluent into the river caused increases in river flows (O'Callaghan, 1990). This increased flow resulted in a connection forming between the Kuils and Eerste Rivers (Wiseman and Simpson, 1989). The Kuils River added stormwater, surface runoff and treated sewage effluent from the Kuils River catchment, which had increased to a great extent. A new housing development (L) also occurred.

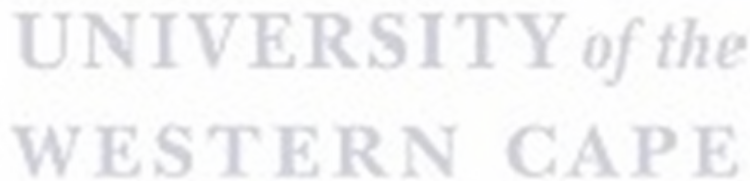
Figure 20. Mouth area and extensive barrier (arrowed) before the flood

The first heavy rainfall occurred during July and the flood peak occurred on the 5th July 2001. The river mouth had increased its width by several meters due to the increased water flow and strong seas. As a result the barrier separating the river from the sea also decreased in width and length (Figures 20 and 21). The right bank located upstream of the estuary had been completely flooded where only the vegetation tops could be seen (Figures 22 and 23).

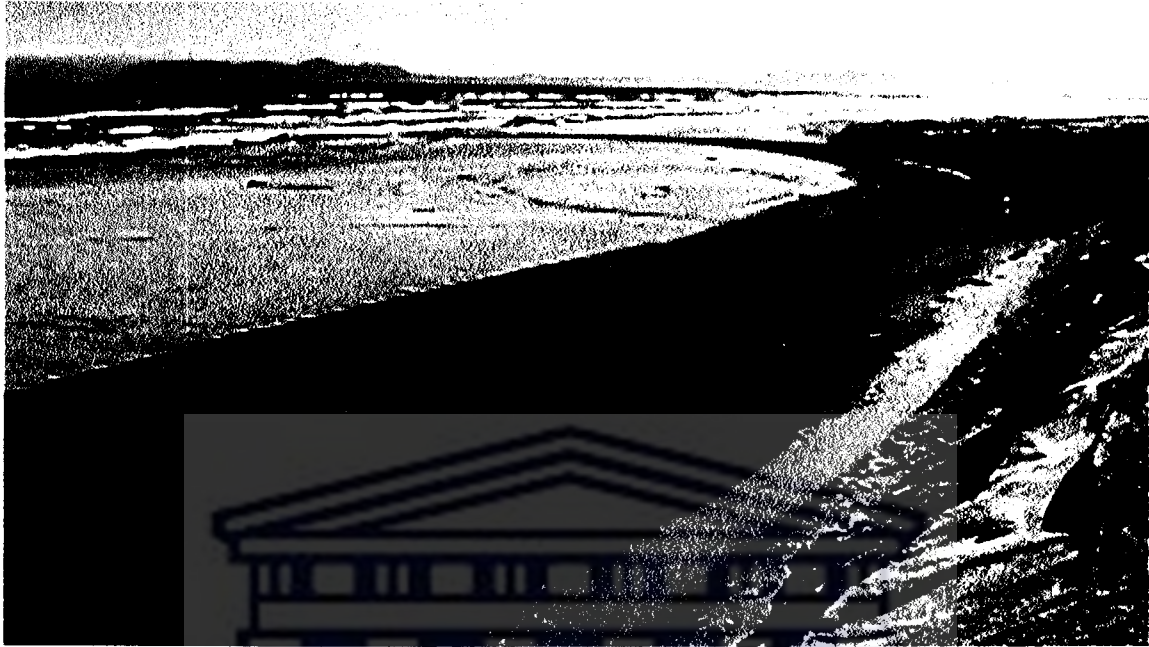
Figure 26. Watercolour during low tide

Water level measurements were recorded on a spring high and low tide and on a neap high and low tide using a measuring staff. The water level readings at transect 1 during the spring tide showed a tidal range of 0.95m. The water level measurements at neap tide showed a 0.50m range. Barrier overwash also occurred. No salinity measurements were recorded to determine how far upstream the tidal influence penetrated but a clear difference in watercolour was observed between the downstream and upstream sections of the estuary. At low tide the river water had a predominantly brown colour (Figure 26) but with tidal influence the watercolour was blue (Figure 27).

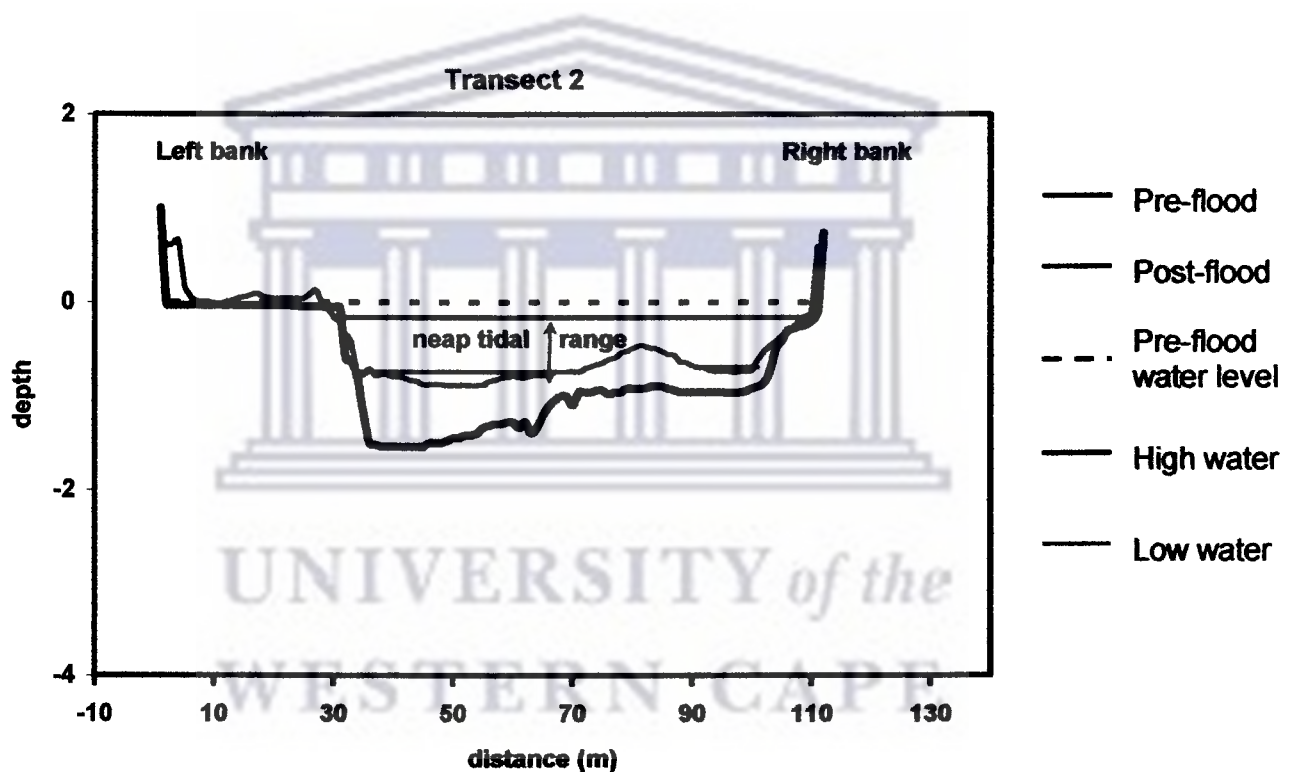
In transect 2 the sandbank occurred at 1-31m on the left side. A steep decent occurred to form the deep section at 36-52m. The sandbank on the right bank side occurred between 79m and 102m with a step to a smaller sandbank between 105m and 111m. A smaller sandbank was found at 6-20m in transect 3. The deepest section occurred between 20m and 49m on the left side of the channel. An extensive sandbank developed on the right side at 57-120m.

Figure 32. Pre- and post-flood cross profiles for transect 2

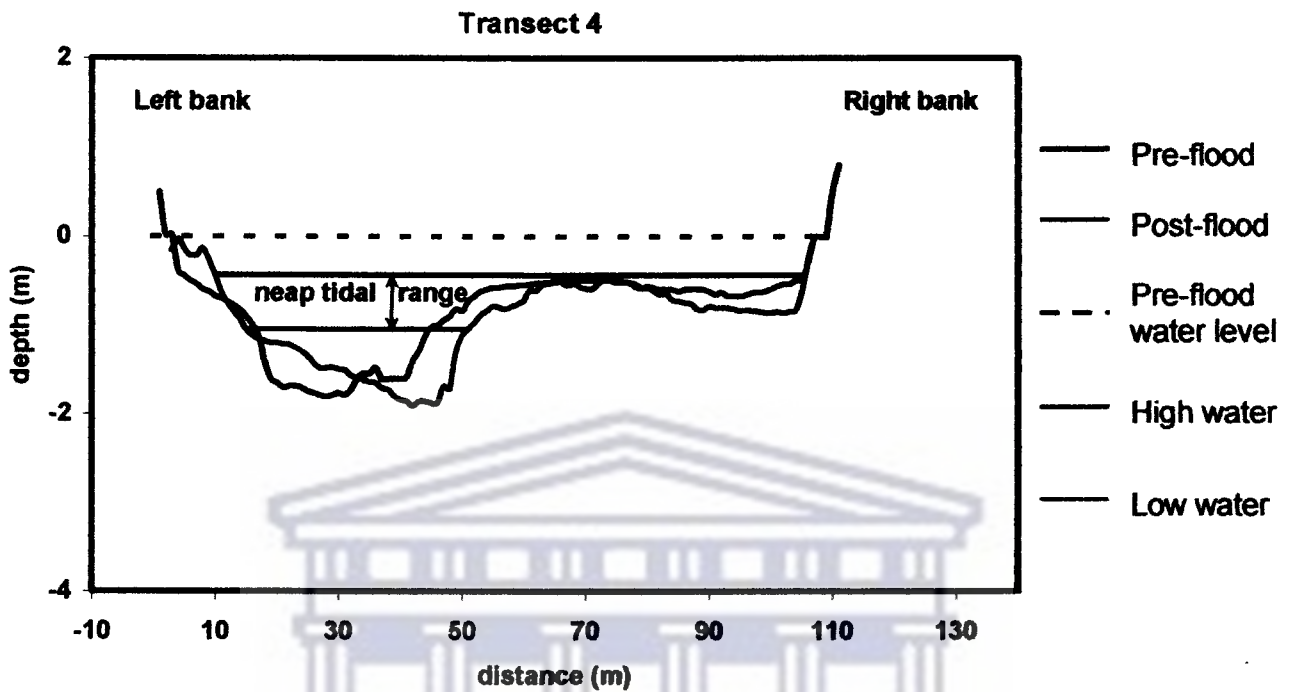
In transect 4 a similar sandbank on the left side as in transect 3 was found between 5m and 19m. An extensive right bank sandbank occurred at 52-104m with the deep section at 20m-34m. Transect 5 showed a sandbank at 6-15m and the deep channel section occurred at 20-36m on the left bank side. A right sandbank was found between 45m and 84m.

Figure 34. Pre- and post-flood cross profiles for transect 4

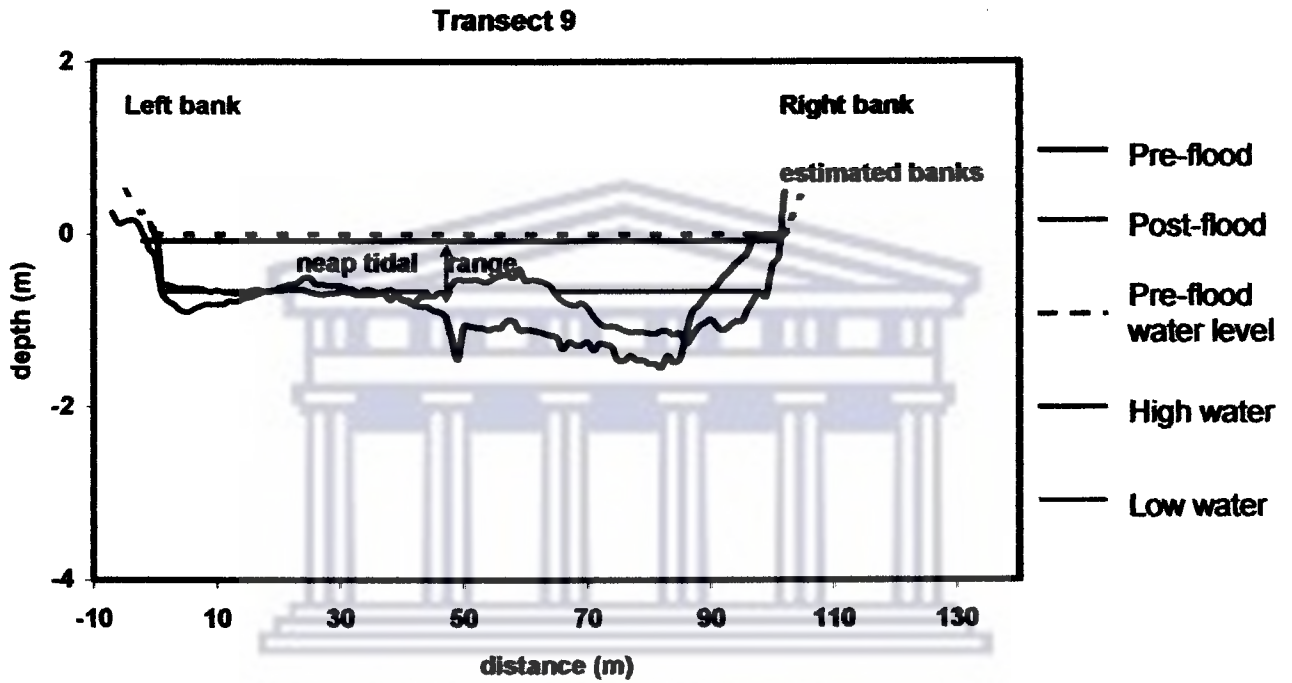
Transect 9 showed an extensive sandbank on the left side between 0-48m. The deep channel section occurred between 75m and 88m on the right side with a smaller sandbank found at 94-100m.

Figure 39. Pre-and post-flood cross profiles for transect 9

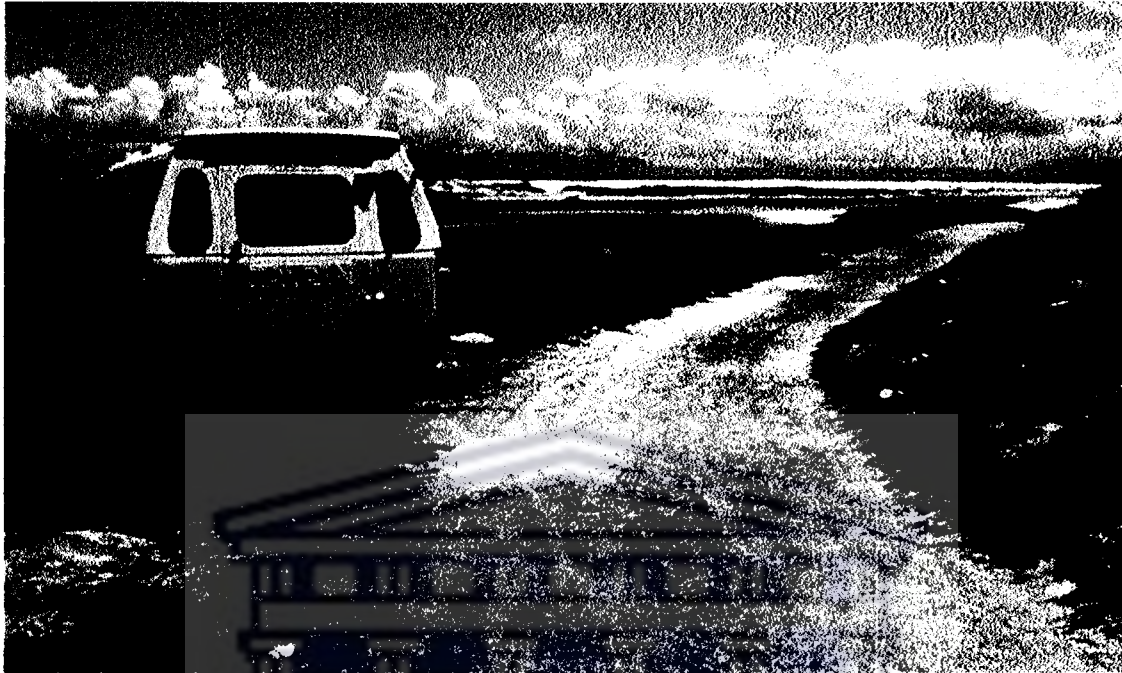
Figure 40. Photograph showing a gravel road area before the flood

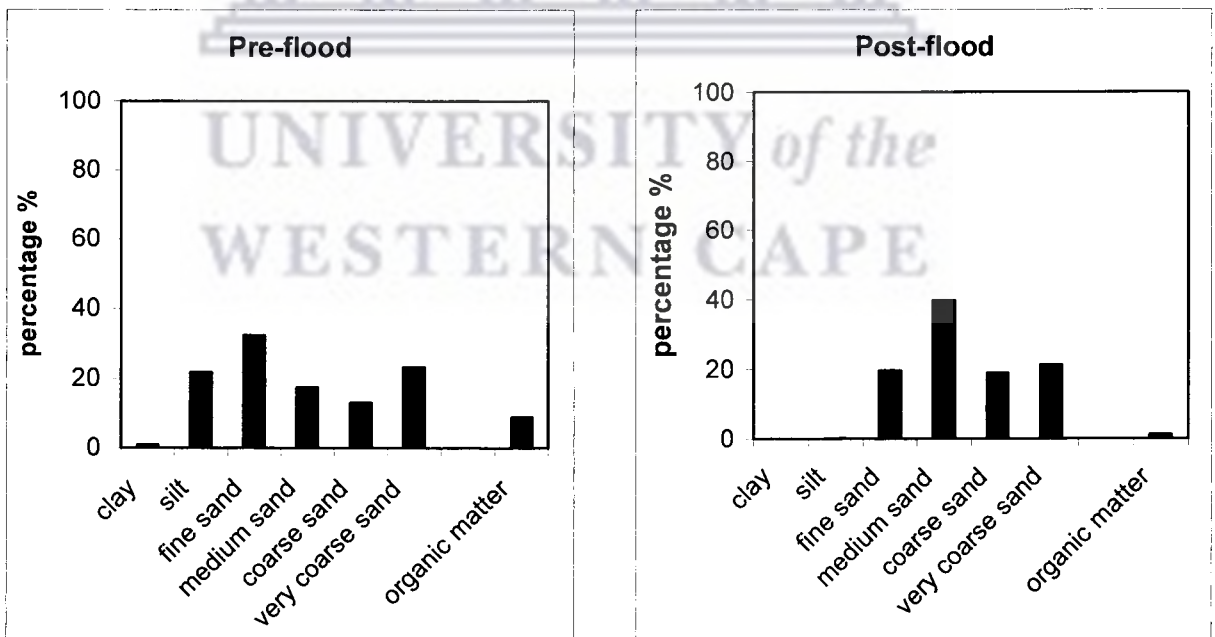
occurring in 1.2. Approximately 11% occurred in 1.3 where 1.4 and 1.5 contained 2% and 6% respectively. Low organic matter percentages occurred throughout except at 1.2, which contained 9%. Sample 1.1, 1.3, 1.4 and 1.5 contained 1.4%, 2.2%, 2% and 2.2% respectively. Less than 3% of clay and approximately 22% of silt occurred only in 1.2.

Figure 45. Pre-and post-flood sediment and organic matter results for sample 1.2
