**INVESTIGATING CHANNEL CHANGE IN RELATION TO LANDUSE  
CHANGE IN THE KLEIN BERG RIVER, TULBAGH**

A thesis submitted in partial fulfillment for the degree of Magister Scientiae in the  
Faculty of Natural Science, University of the Western Cape

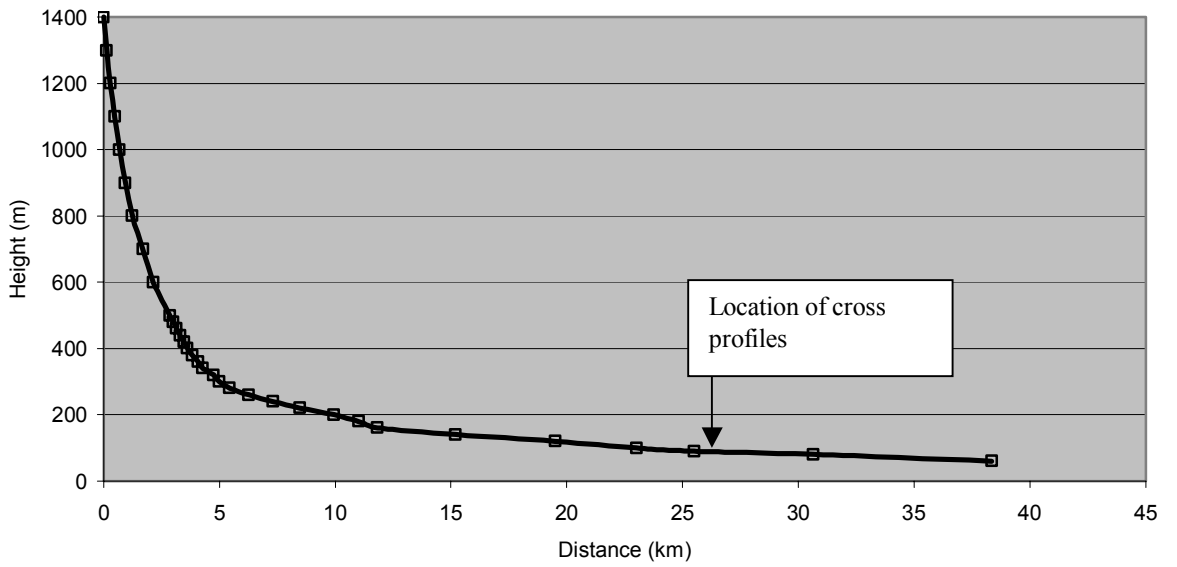
Figure 3.2 Long profile of the Klein Berg River

A long profile of the Klein Berg River was compiled from the following 1: 50 000 topographical maps: 3319AA Groot-Winterhoek and 3319AC Tulbagh. The long profile is drawn from the Winterhoek Mountains before the confluence with the Berg River (Figure 3.2).

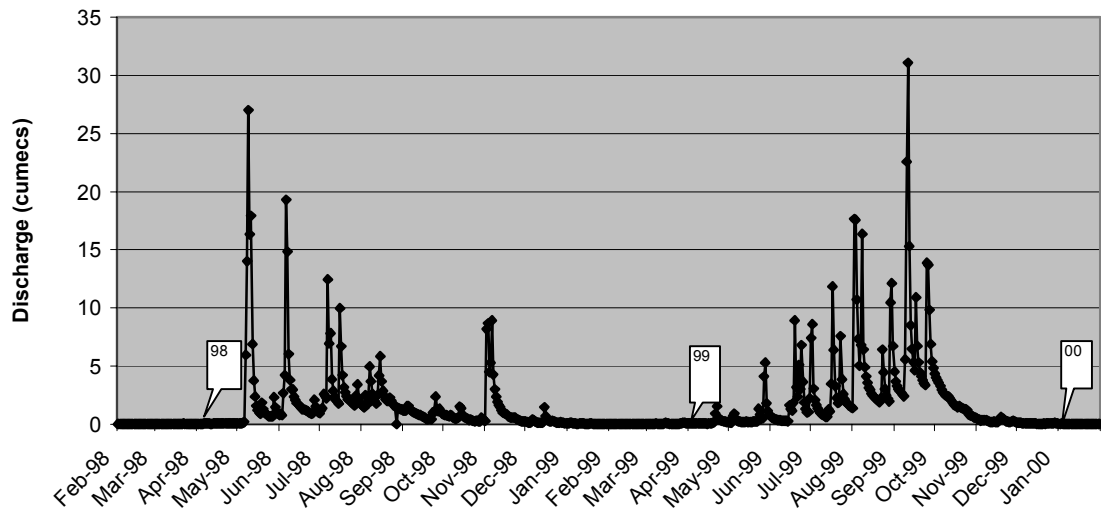
Figure 5.1 Discharge values ( $m^3/s$ ) from 1 February 1998 to 31 January 2000

February 2000, which thus reflects two winter seasons. The months when the river was surveyed is indicated on the figure. What is interesting to note is that the winter runoff for 1998 starts off with a peak discharge and gradually decreases, while the discharge for winter 1999 increases to the peak discharge.

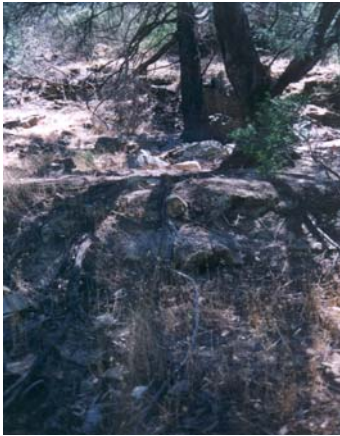
Plate 5.1 Left bank (profile 1)

<b>Left Bank (%)</b>	<b>Right Bank (%)</b>
<b>Very coarse sand</b>	0.8	10.1
<b>Coarse sand</b>	15.5	15.3
<b>Medium sand</b>	52.6	30.9
<b>Fine sand</b>	22.4	27.5
<b>Very fine sand</b>	7.2	10.8
<b>Silt and Clay</b>	1.5	5.5

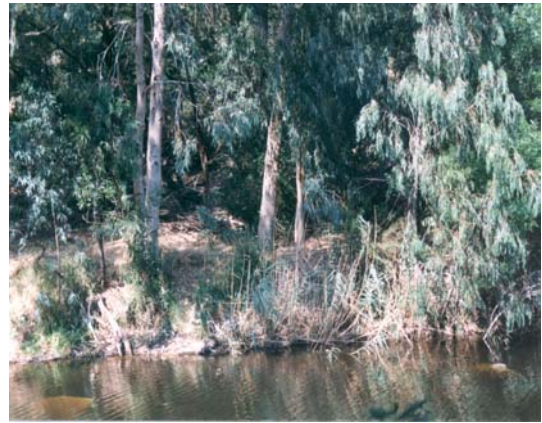
Plate 5.2 Right bank (profile 1)

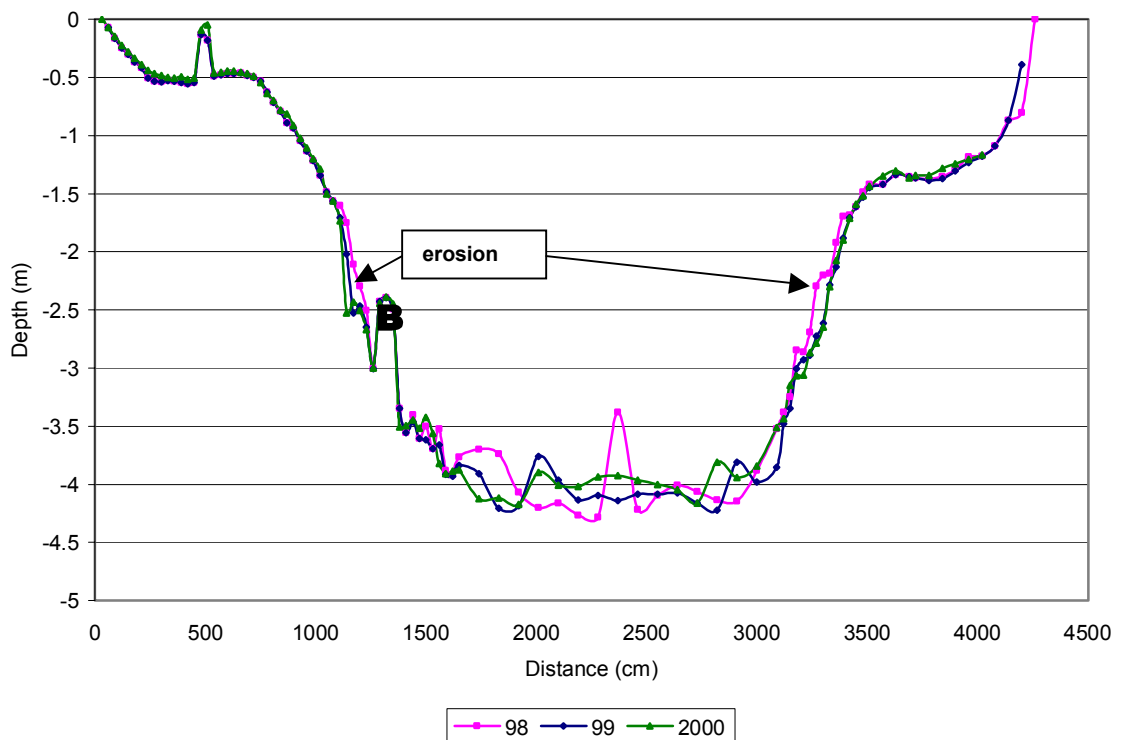
Figure 5.2 Cross Profile 1 (looking upstream)

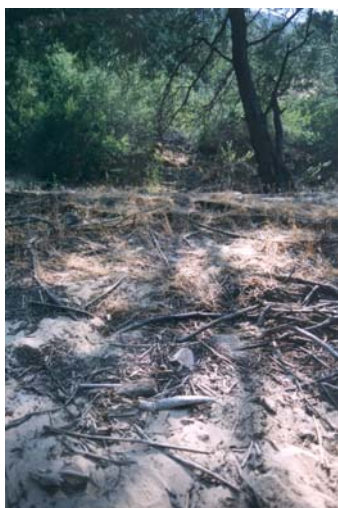
Plate 5.3 Left bank (profile 2)

<b>Left Bank (%)</b>	<b>Right Bank (%)</b>
<b>Very coarse sand</b>	5.5	2.4
<b>Coarse sand</b>	9.3	10.0
<b>Medium sand</b>	48.6	35.0
<b>Fine sand</b>	25.9	34.1
<b>Very fine sand</b>	7.4	13.6
<b>Silt and Clay</b>	3.2	4.8

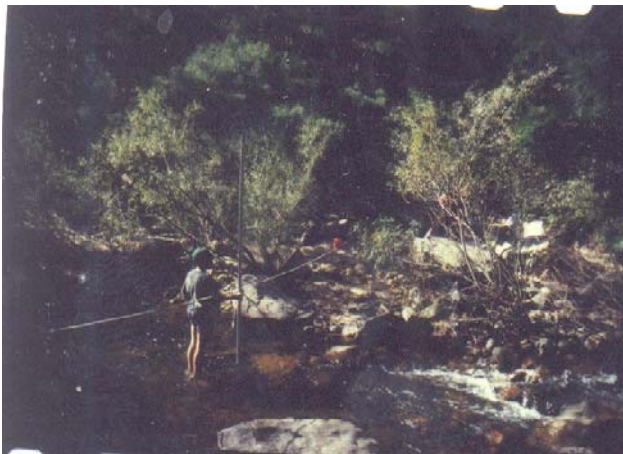
Plate 5.5 Profile 3

<b>Left Bank (%)</b>	<b>Right Bank (%)</b>
<b>Very coarse sand</b>	44.0	11.1
<b>Coarse sand</b>	40.5	16.2
<b>Medium sand</b>	13.1	40.7
<b>Fine sand</b>	1.9	20.6
<b>Very fine sand</b>	0.4	6.8
<b>Silt and Clay</b>	0.1	4.5

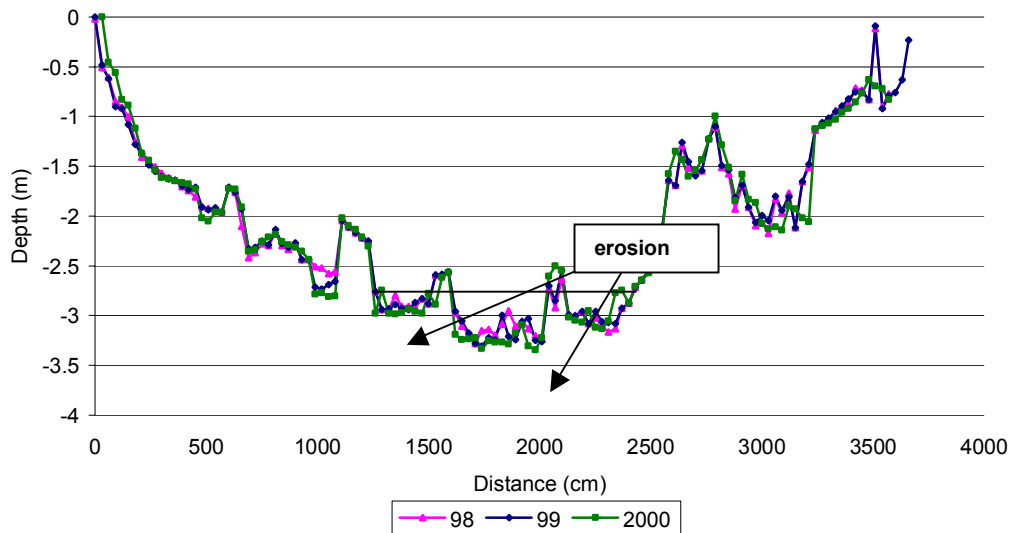
Figure 5.4 Cross-profile 3 (looking upstream)

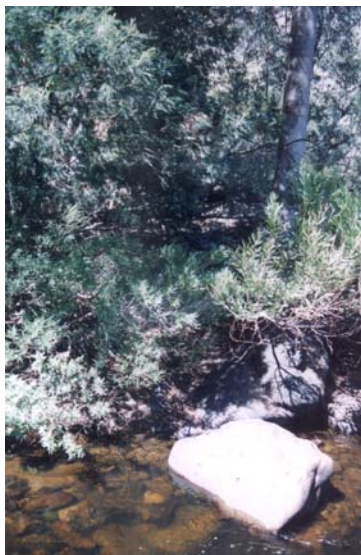
Plate 5.6 Left bank (profile 4)

<b>Left Bank (%)</b>	<b>Right Bank (%)</b>
<b>Very coarse sand</b>	2.4	26.0
<b>Coarse sand</b>	43.2	7.6
<b>Medium sand</b>	47.0	27.6
<b>Fine sand</b>	5.2	24.3
<b>Very fine sand</b>	1.6	8.7
<b>Silt and Clay</b>	0.6	5.9

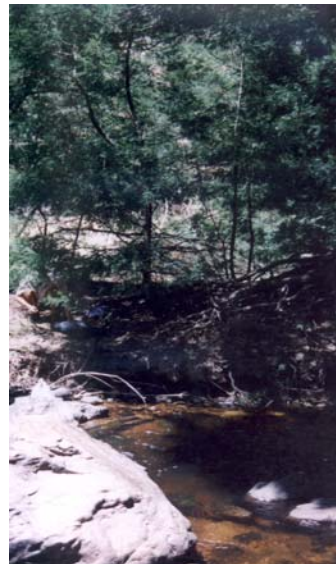
Plate 5.7 Right bank (profile 4)

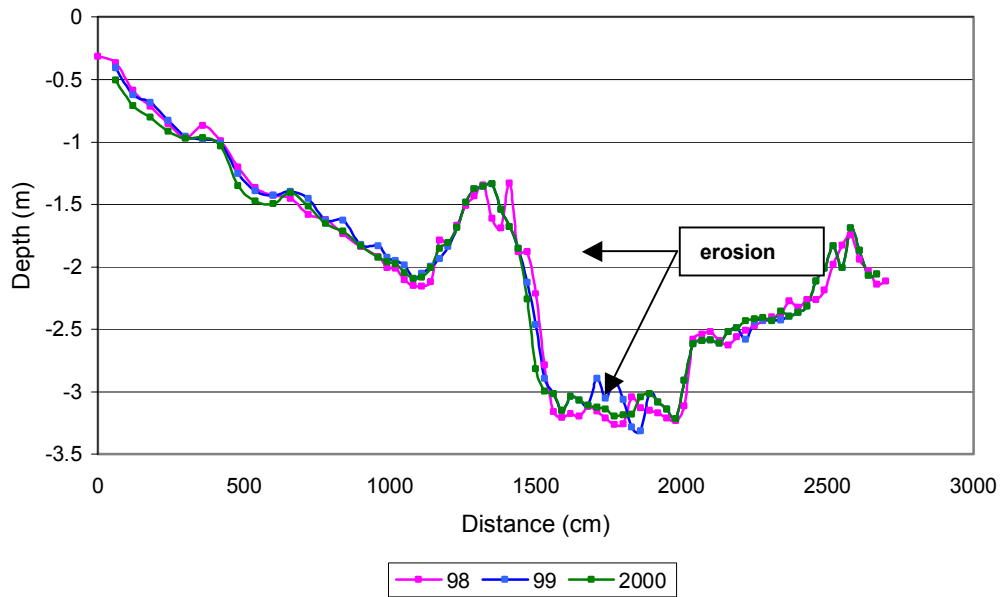
Figure 5.5 Cross-profile 4 (looking upstream)

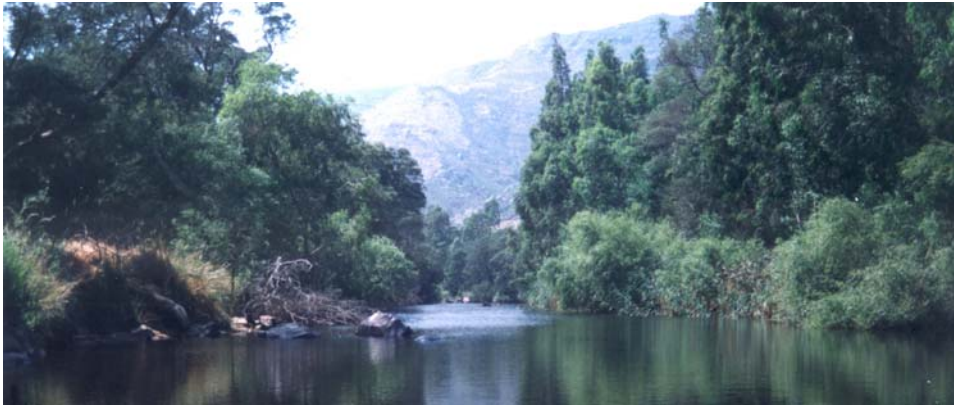
Plate 5.8 Riparian vegetation along the Klein Berg River (near Nuiwekloof Pass)

The riparian vegetation in the Nuiwekloof Pass consists chiefly of trees and shrubs. The trees are primarily of alien species such as *Acacia* and *Eucalyptus*. This vegetation forms a narrow but dense, closed canopy along the watercourse (Plate 5.8).

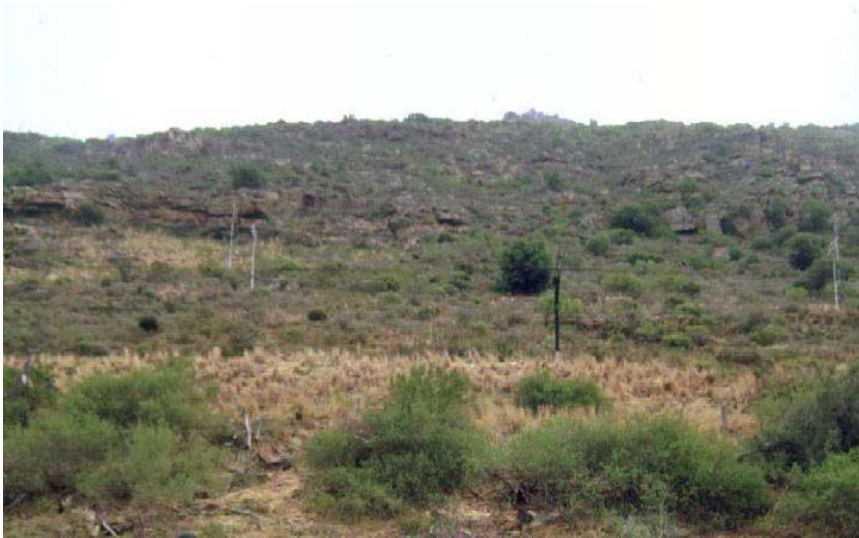
Plate 5.9 Indigenous vegetation along the mountain slopes of the Klein Berg River catchment

The trees extend from along the banks across the flood plains to the steep valley slopes. The invasive alien vegetation growth is only dominant from the river to the roads on either side. The trees along the banks reach impressive heights to as much as 30m and provide shade for the many organisms found in the river channel. Vegetation, such as trees and plants, was also found on bars within the river channel. The invasive woody vegetation tends to be concentrated along the banks and flood plains, and decreases in density as one moves away from the river up the valley slopes. The presence of indigenous trees and shrubs become more dense along the valley slopes. Vegetation along the mountain slopes, that is the area beyond the roads and railway line, is quite distinct from the riparian vegetation and mainly consists of Mountain fynbos (Plate 5.9). A common occurrence in rivers where the riparian zone is dominated by trees is the presence of large organic debris. Debris can be found in the river, on the banks and on the flood plain of the Klein

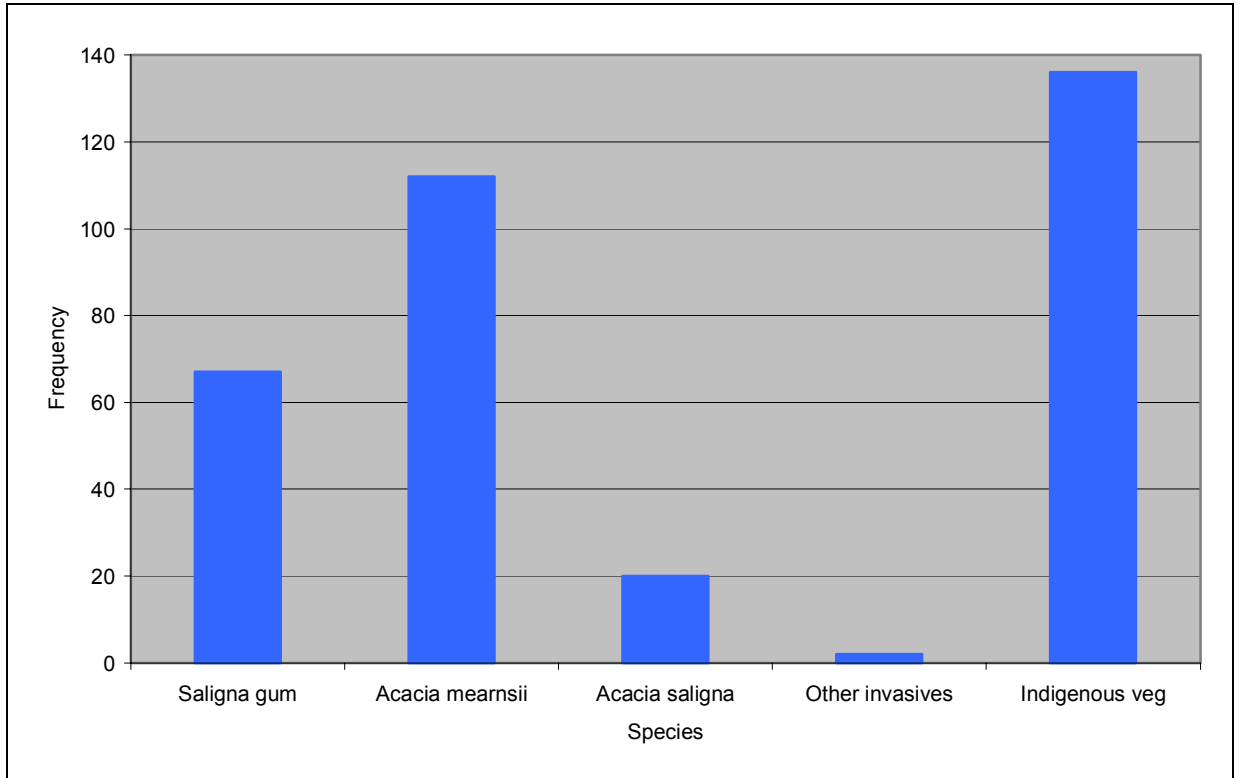
Figure 5.10 Frequency of vegetation species

in the area, with a total of 112 trees recorded. A total of 67 trees of the species *Saligna gum* was recorded while the Port Jackson (*Acacia saligna*) numbered 20. A list of all species found within the study area can be found in Appendix 3.

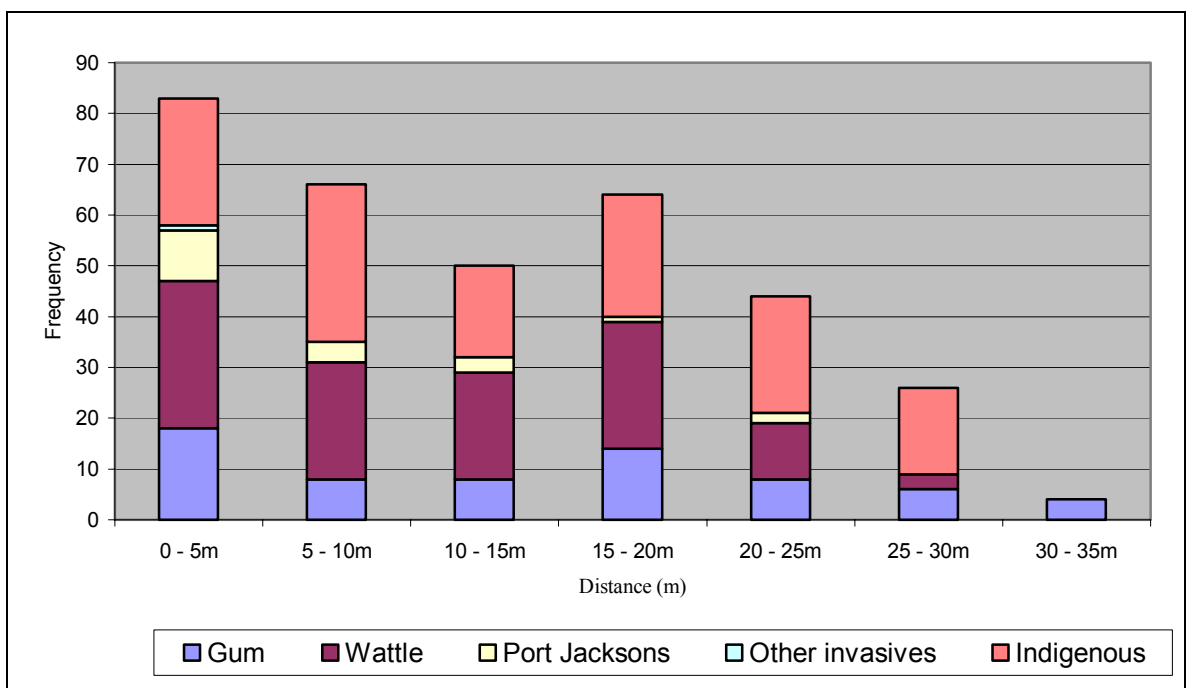
Figure 5.11 Change in vegetation distribution

A change in the distribution of species is observed as one moves away from the bank and floodplain towards the slopes of the valley. Figure 5.11 illustrates the frequency of each species within the different quadrants/intervals from the banks to the valley slopes. According to figure 5.11 the frequency of indigenous species within each quadrant is more than each of the individual alien species except in the 15 - 20 m quadrant. A comparison of indigenous and alien vegetation reveals that the first 20 m from the river channel is dominated by invasive alien species. All the species decrease in frequency as one moves from the banks to the valley slopes.

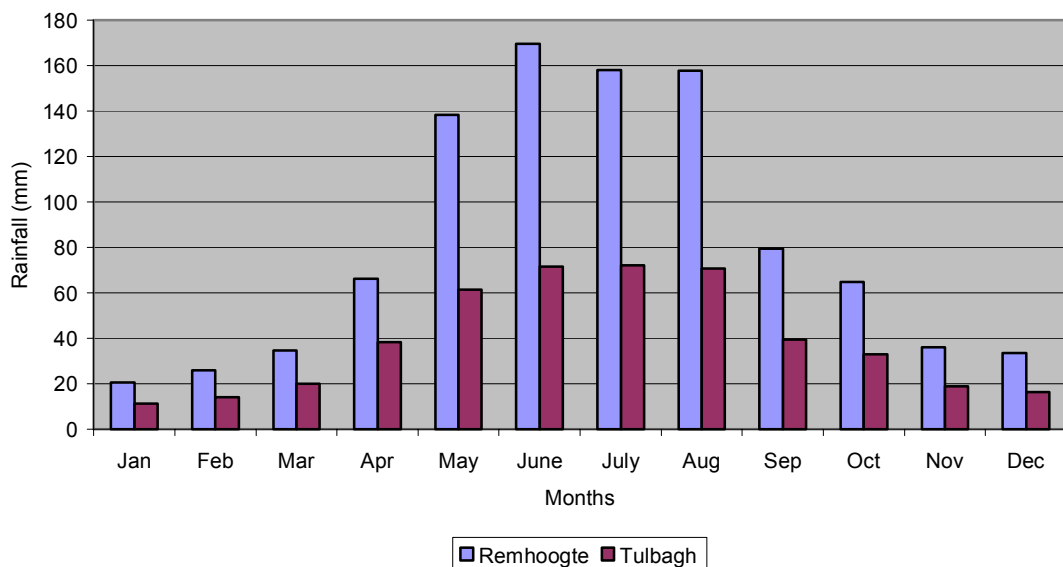
Figure 5.12 Mean monthly rainfall in mm for Tulbagh and Remhoogte (1954 – 2003). (Source: South Africa Weather Service)

The South African Weather Service provided data for two rainfall gauges that are located within the Klein Berg River catchment. Details of the stations are provided in Table 4.2. Both rain gauges have a 50-year record, dating from 1954 to 2003. The location within the catchments as well as an elevation difference has a marked influence on the values for the two rainfall gauges. Fig 5.12 is a bar graph showing mean rainfall from January to December for the two stations. Remhoogte, which is situated within the upper reaches of the Klein Berg River, and has a height of 370m above sea level, is close to the northern mountain range and shows a higher average rainfall than Tulbagh Police station. Tulbagh Police station is situated within the center of the catchment at a height of 155m above sea level. Despite the difference in rainfall values, figure 5.12 clearly shows a correlation between the rainfall values. A positive correlation of 0.8275 was determined for the two rainfall gauges.

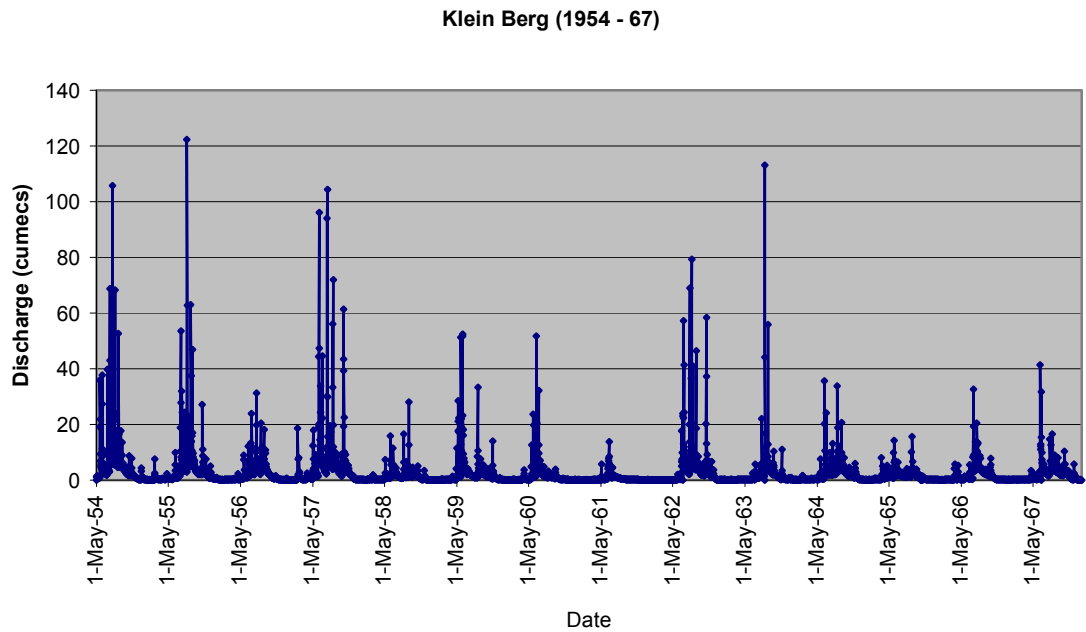
Figure 5.14 Daily discharge data for a period of 14 years from 1954 to 1967. (Source: DWAF)

The 14-year period from 1954 to 1967 (figure 5.14), indicate that 50% of all flows (median) were higher than 0.674 m<sup>3</sup>/s. This indicates relatively higher flows if compared to the following two periods of flow. However, a reason for this higher value could be due to the fact that the relatively drier months of January to May in 1962 were not included due to missing data.

It is evident from the graph (fig 5.14) that the hydrological year of 1960/61 was the lowest. For this year an average of  $0.494 \text{ m}^3/\text{s}$  and a median of  $0.167 \text{ m}^3/\text{s}$  was calculated. The low discharge for this hydrological year corresponds to the low rainfall received for Tulbagh (23.18mm) and Remhoogte (46.31mm).

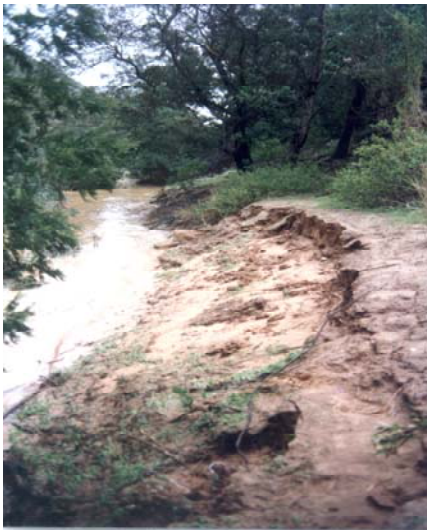
Plate 6.1 Erosion during high flow

The presence of vegetation or lack thereof is very important in bank stability. The lack of vegetation along the banks allows the detachment of individual particles from the bank

during high flows (Plate 6.1). The woody invasive alien species prohibits the growth of indigenous vegetation and as a result the ground is bare and susceptible to erosion especially during high flows. Plate 6.2 illustrates the growth of a black wattle on the bank of the river. Surface vegetation is sparse and thus during high flows the area is susceptible to erosion.

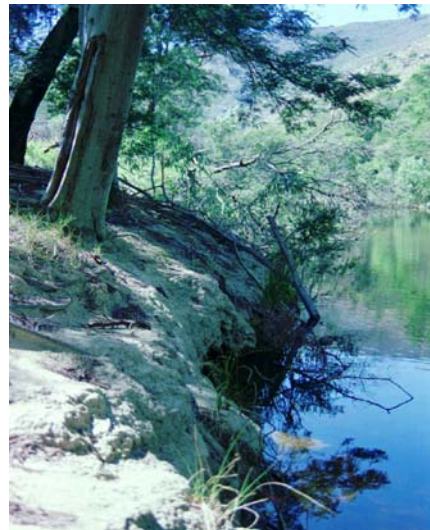
Plate 6.2 Black wattle on bank

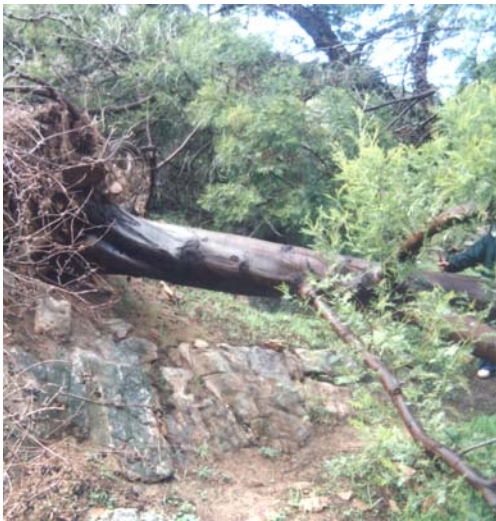
Plate 6.3      Treefall due to thin soil cover over bedrock

Treefall was observed in the study area and plays a very important role in soil erosion and bank stability. Within the study reach the woody alien species were especially susceptible to treefall where their rooting systems were shallow. Plate 6.3 illustrates treefall of a black wattle due to a shallow rooting system resulting from bedrock close to the surface. As a result of the shallow rooting systems, the force of the wind easily uproots the trees. As the tree is uprooted the soil is eroded. A consequence of treefall along the banks was firstly the destabilization of the banks. Within the channel, the fallen tree obstructs streamflow and also causes the deposition of sediment and debris (Plate 6.4). The weight of trees along the banks plays an important role in bank instability as bank collapse may occur if

the weight reaches a critical weight.

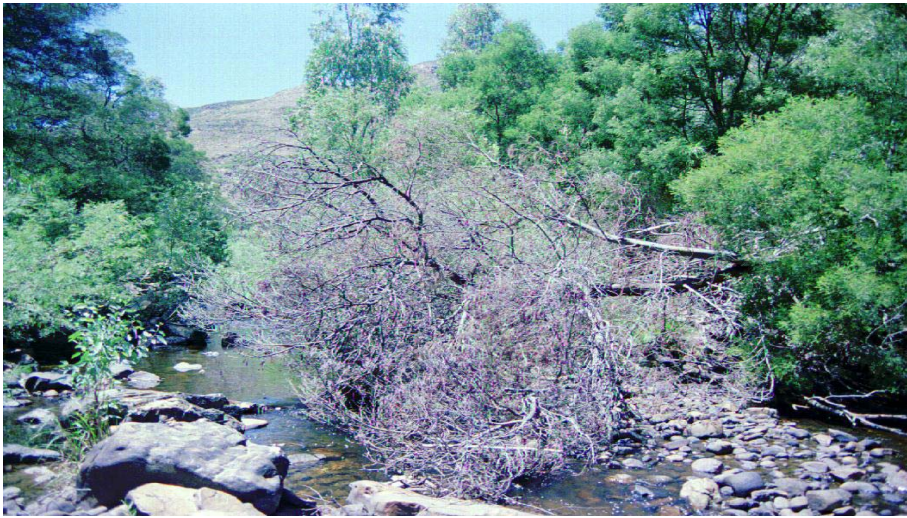
Plate 6.4 Treefall in the river channel

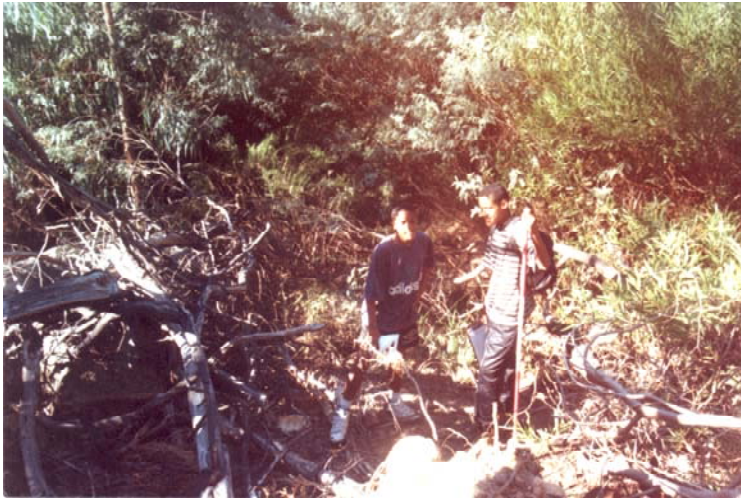
Plate 6.5 Large organic debris on floodplain

Organic debris is also located on the floodplain where it was deposited by high flows occurring during the winter seasons. A measurement of one of these debris loads consisting of logs and branches revealed an area of  $18\text{m}^2$  (6 metres by 3 metres) with a height of almost 2.5metres. These debris loads are mobilized during high flows (Plate 6.6). Debris within the channel can also act as a reservoir, allowing sediment deposition.

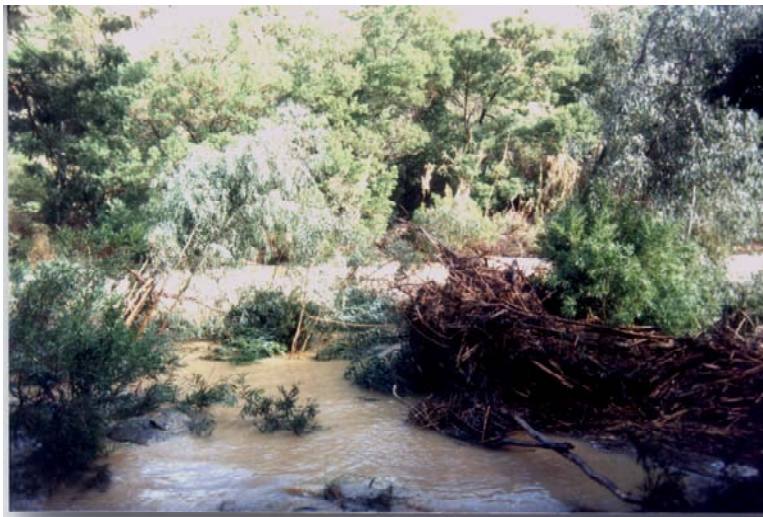
Plate 6.6 Large organic debris during high flow

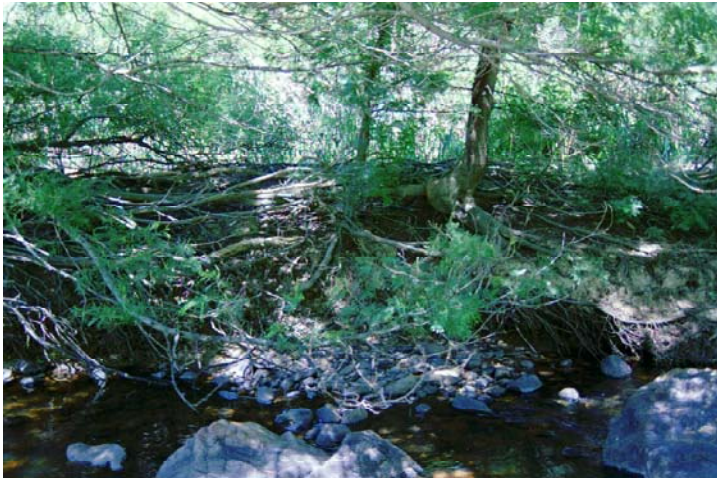
Plate 6.7      Complex and extensive rooting system

basically cover the major part of the banks, thus protecting it from the force of the water. The rooting system of the large invasive trees is very prominent, and may either have a positive or negative impact on the banks depending on the position of the roots and on the flow of water.
