**THE EFFICACY OF ROTARY AND MANUAL  
INSTRUMENTS IN ROOT CANAL DEBRIDEMENT.**

A Mini-Thesis Submitted in Partial Fulfilment for the  
MChD degree in Prosthodontics at the Faculty of  
Dentistry, University of the Western Cape

# THE EFFICACY OF ROTARY AND MANUAL INSTRUMENTS IN ROOT CANAL DEBRIDEMENT

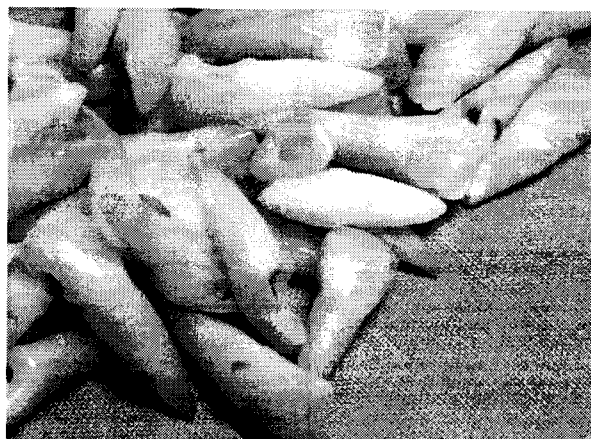
Fig 4.1 Extracted maxillary incisors

Ninety extracted maxillary incisors were randomly divided into three groups, where the first forty were debrided using K-Files®, the next forty debrided using ProTaper® nickel-titanium files, and the final ten teeth were used as negative controls.

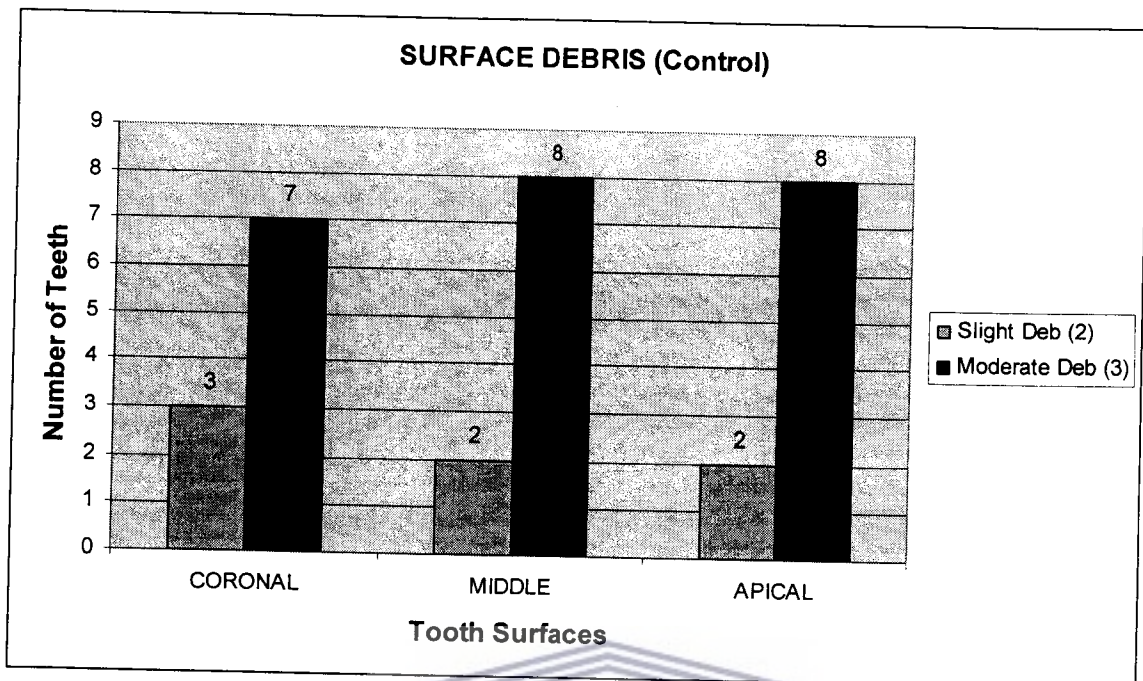
Graph 5.1 Control Surface Debris graphically illustrated

The above is the illustration of the amount of surface debris that remained on the control teeth following only extirpation, where only the barbed broach was used.

In the control debris group, all surfaces showed a presence of debris. Three of the coronal surfaces, two of the middle third and two of the apical surfaces had a score of two while seven of the coronal, eight of the middle and eight of the apical third surfaces had a score of three, indicating moderate debris covering less than 50% of the specimen. However, there was no smear layer formation, because only a barbed broach was used.

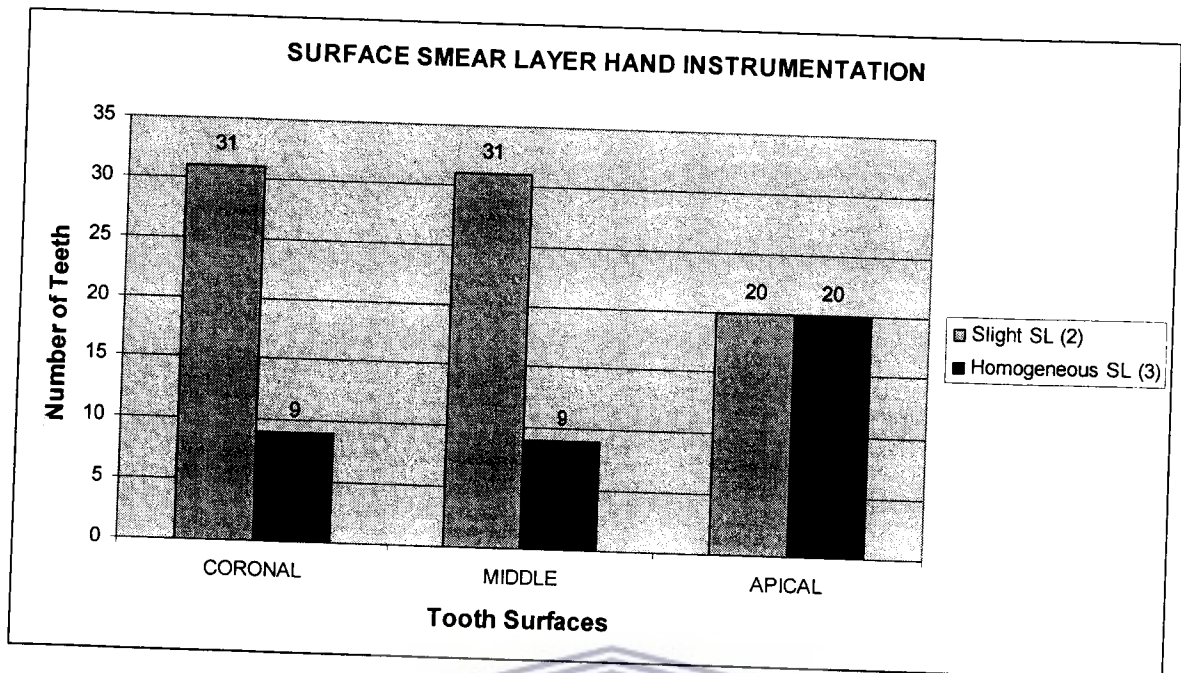
Graph 5.4 Smear Layer Scores Hand instrumented group  
Graphically Illustrated

The X-axis represents the tooth surfaces that were examined in the hand debridement group for smear layer assessment.

In the apical third, no surface had a score of 2, only 1 surface had a score of 3, 6 surfaces had a score of 4 and 33 surfaces had a score of 5.

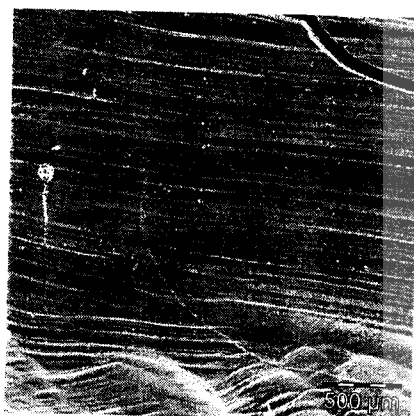
Fig 5.17 was assigned a value of 3, where moderate amounts of debris were left behind, covering less than 50% of the sample surface. Fig 5.18 was assigned a score of 2, where only slight debris was seen covering the surface of the sample.

From the above slides it can be seen that the coronal third of the tooth tends to be cleaner than all the other surfaces, and the apical third has the highest amount of debris remaining in the rotary instrumented group.
